# SILVER LAKE DRAINAGE IMPROVEMENTS STUDY FINAL REPORT

New York State Governor's Office of Storm Recovery (GOSR) –  
Funded Disaster Recovery

Nassau County Department of Public Works

**DECEMBER, 2018**

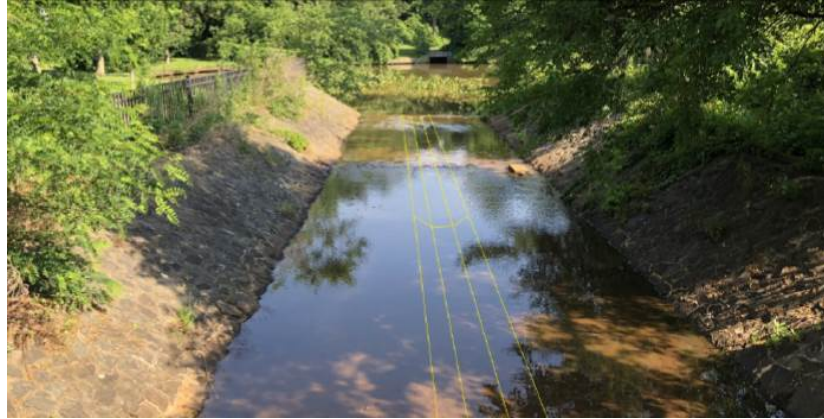
Currently the existing trapezoidal channel north of Wateredge Avenue, restricts fish passage during normal flow conditions as a result of inadequate depth of flow. This design component would address the condition by constructing a low flow channel below the invert of the existing trapezoidal channel. The fish passage channel would be sized to handle the measured base flow under dry weather conditions and would require a depth of approximately 12” for fish passage. In addition to the modifications to the trapezoidal channel, a small weir would need to be constructed across Parsonage Creek just south of the Wateredge Avenue culvert in order to increase the minimum depth of base flow during dry-weather conditions.

***Component 4. Trapezoid Channel south of Caroline’s Pond Currently Restricting Fish Passage. Proposed Location of Low Flow Channel for Fish Passage Depicted***

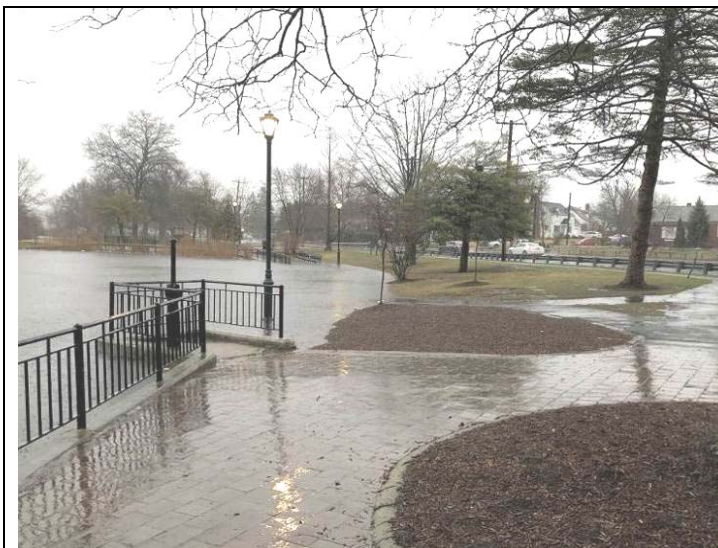
On March 2, 2018 significant flooding was observed at Silver Lake Park during peak high tide (Photo 1 & 2). On this date, the area experienced a combination of a 2.16 inch 24-hour rainfall and the local tidal gauges in Freeport, NY recorded a maximum water surface elevation of 4.231 feet (NAVD88). The flooding observed in the lake was approximately 1.2 feet above the top of bulkhead, which has a top of wall elevation of approximately 3.0 (NAVD88). The perimeter walkway around the pond was completely under water.

Photo 1. March 2, 2018 flooding observed in Silver Lake Park east of existing weir. Walkway is completely inundated with flood waters. Photograph taken at peak high tide.

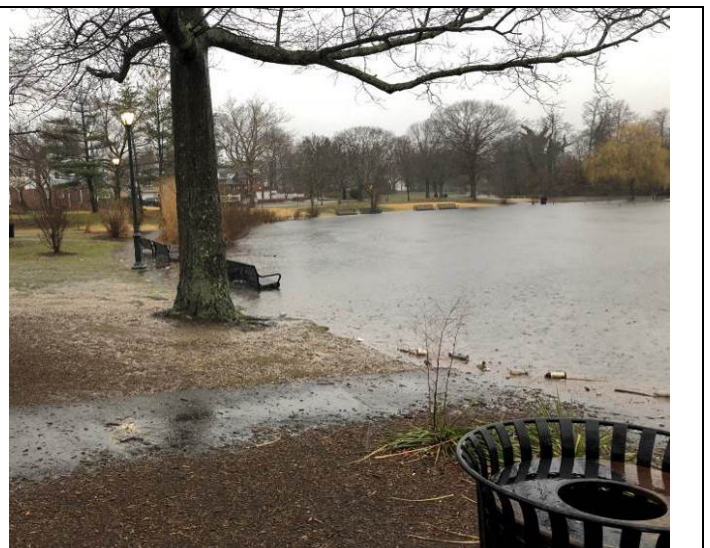
Photo 2. March 2, 2018 flooding observed in Silver Lake Park west of existing weir. Walkway and benches are underwater and floatable trash is evident at the edge of the floodwaters.

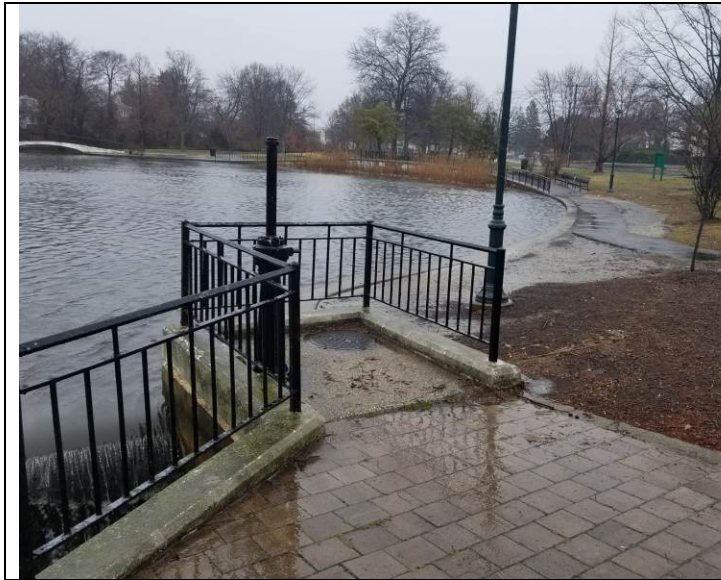
Later in the day during the low tide period and while it was still raining, the design team revisited the site. It was observed that even though it was still raining, the flood waters receded below the top of bulkhead. This indicates that tidal surge was the main contributor to the flooding that occurred.

Photo 3. March 2, 2018 at Silver Lake Park east of existing weir. Flood waters have receded below the top of bulkhead elevation. Photograph taken at low tide.

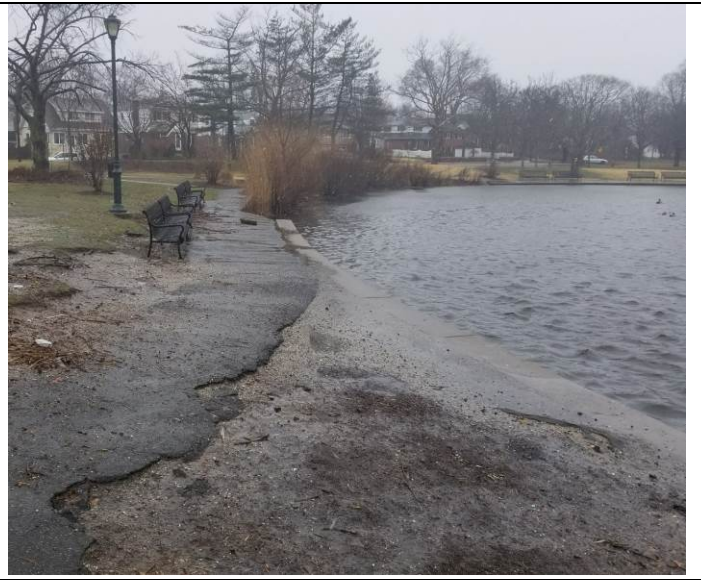
Photo 4. March 2, 2018 at Silver Lake Park west of existing weir. Flood waters have receded below top of bulkhead elevation. Photograph taken at low tide.

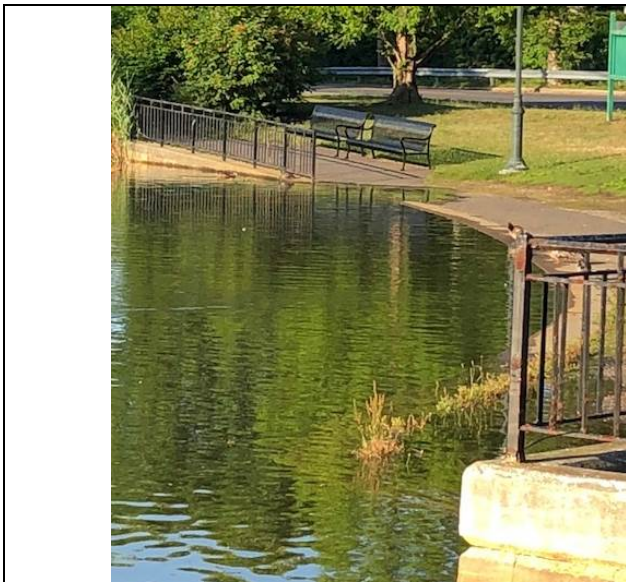
On July 10, 2018, minor flooding of Silver Lake Park was observed and documented by Nassau County DPW (Photo 5 & 6). On this date, there was no rain recorded but an offshore storm combined with a period of time three days before the new moon resulted in the tide reaching an elevation of 3.12' (NAVD), which is slightly above the top of bulkhead elevation.

Photo 5. July 10, 2018 at Silver Lake Park east of existing weir. Tidal surge has breached the top of the existing bulkhead wall (top of wall = 3.0' NAVD)

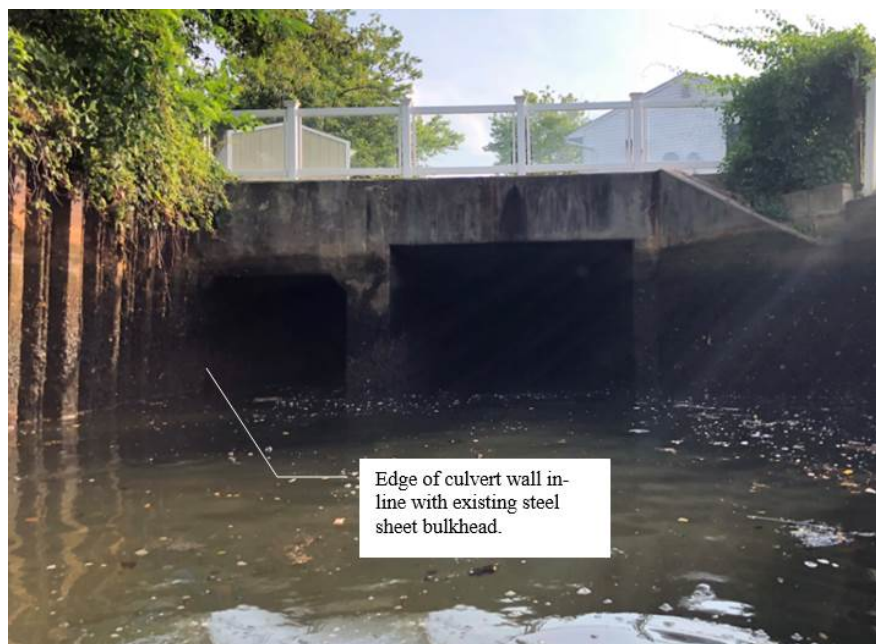
As depicted on the 1980 record plans and shown in the photograph below the culverts terminate at the north end of Parsonage Creek Canal without any tide gates. Also evident is that the western wall of the 6'x6' culvert terminates basically in-line with a deteriorated steel bulkhead leaving insufficient room for a tide gate to be installed on the 6'x6' culvert.

**Photo 7. Photograph of existing box culvert outfalls at Parsonage Creek Canal.**

- Tide gates at outlet culverts – A traditional “flap type” tide gate can be installed at Parsonage Canal on the end of the existing 10’x7’-3” concrete box culvert. However, due to space restrictions in the canal, a tide gate on the western 6’x6’ box culvert cannot be installed in the canal. In order to install a tide gate on the 6’x6’ culvert, it must be installed in the park south of the Silver Lake weir and north of Foxhurst Avenue. It was recommended that this tide gate be a self-regulating tide gate (SRT) that will allow the normal tidal flushing of the lake up to mean high water and close at the desired tidal elevation for upland protection.

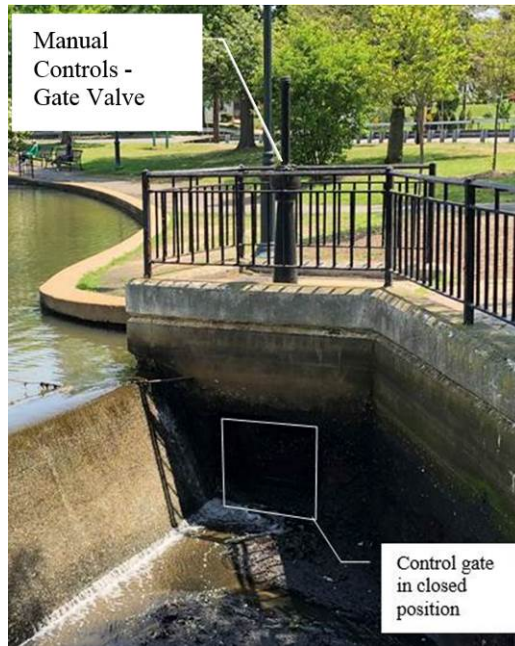
One control gate is located at the east side of the weir structure. The purpose of a control gate is typically to allow the lake to be drained for maintenance or for lowering the water surface elevation prior to an anticipated rainfall event for additional storage capacity. Based on the elevation of the bottom of the control gate, this feature would allow approximately 2 - 4 feet of the lake to be drained. The control gate was not able to be operated during the study period, and it is unknown if it is still in working condition.

**Photo 9. Photograph of existing control gate at the east side of the weir**

- Refurbish or Replace Existing Control Gate at Weir – The concept of refurbishing or replacing the existing control gate located on the east side of the weir was discussed. The purpose of this improvement would be to have the ability to lower the lake elevation prior to an impending storm event so that additional stormwater

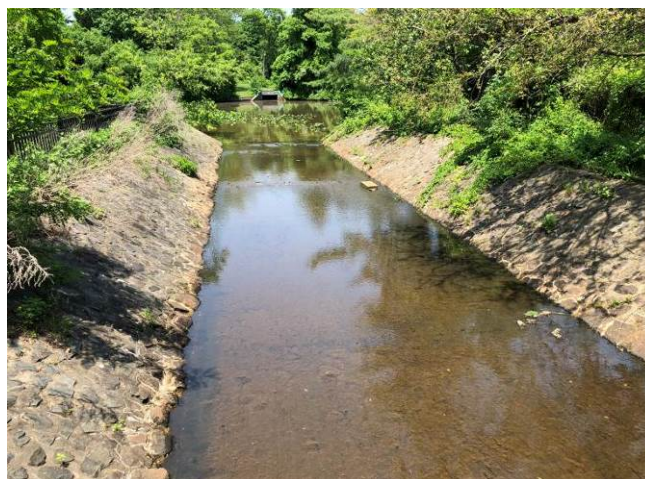
**Photo 10. Photograph taken from Wateredge Avenue looking north into Caroline’s Pond. Concrete trapezoidal channel in forefront controls water surface elevations. Shallow base flow under normal conditions is not conducive for fish passage.**

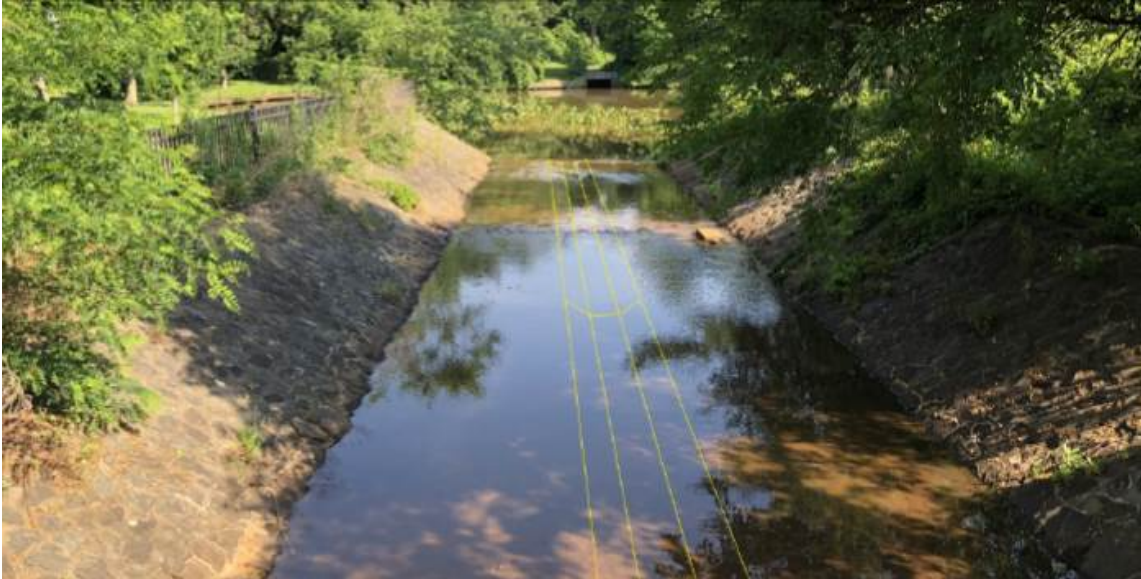
**Figure IV-12. Trapezoid Channel south of Caroline’s Pond Currently Restricting Fish Passage. Proposed Location of Low Flow Channel for Fish Passage Depicted**
