# Appendix 3.1-6

## Elevator Pit Investigation

**Subject:** Freight car pit

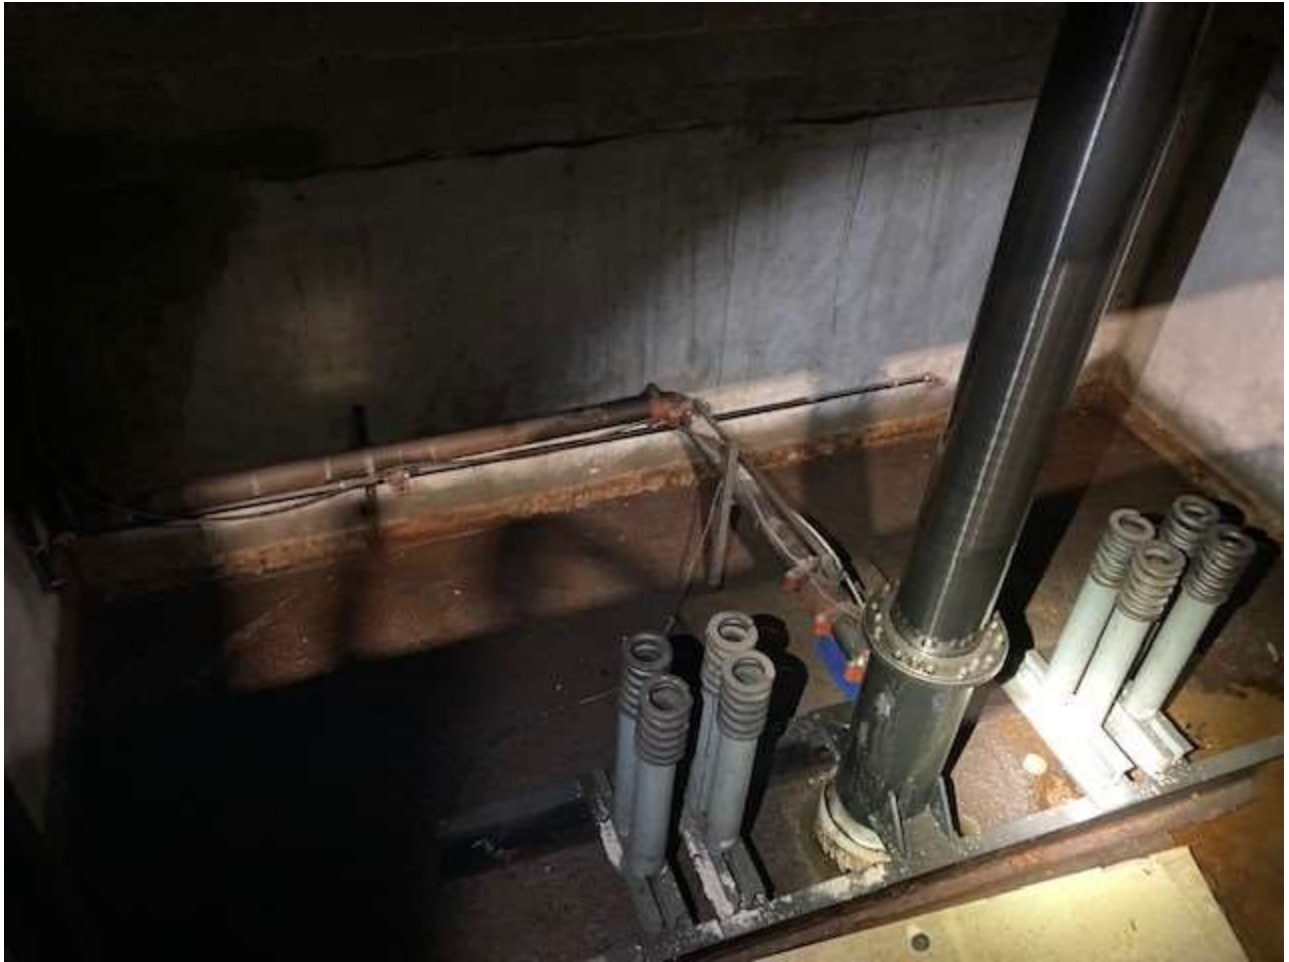
As per yesterday's Inspection with Otis Elevator, they inspected and tested to ensure that the hydraulic shaft and shaft seal was not compromised (leaking or burr's). The shaft, seal and the hydraulic recovery pump are mechanically in good operational condition.

After future investigation to figure out how the water was entering the shaft, the Otis supervisor was able to point out that the shaft is in a sleeve which allows water from the earth to enter and out of that shaft sleeve.

Please see recent photo of shaft and sleeve.
