# Nassau County Stormwater Management Program

## **CEDAR SWAMP CREEK subwatershed Stormwater Runoff Impact Analysis AND CANDIDATE SITE ASSESSMENT REPORT**

***FINAL – October 1, 2007***

**CASHIN ASSOCIATES, P.C.**  
*Engineering • Planning • Construction Management*

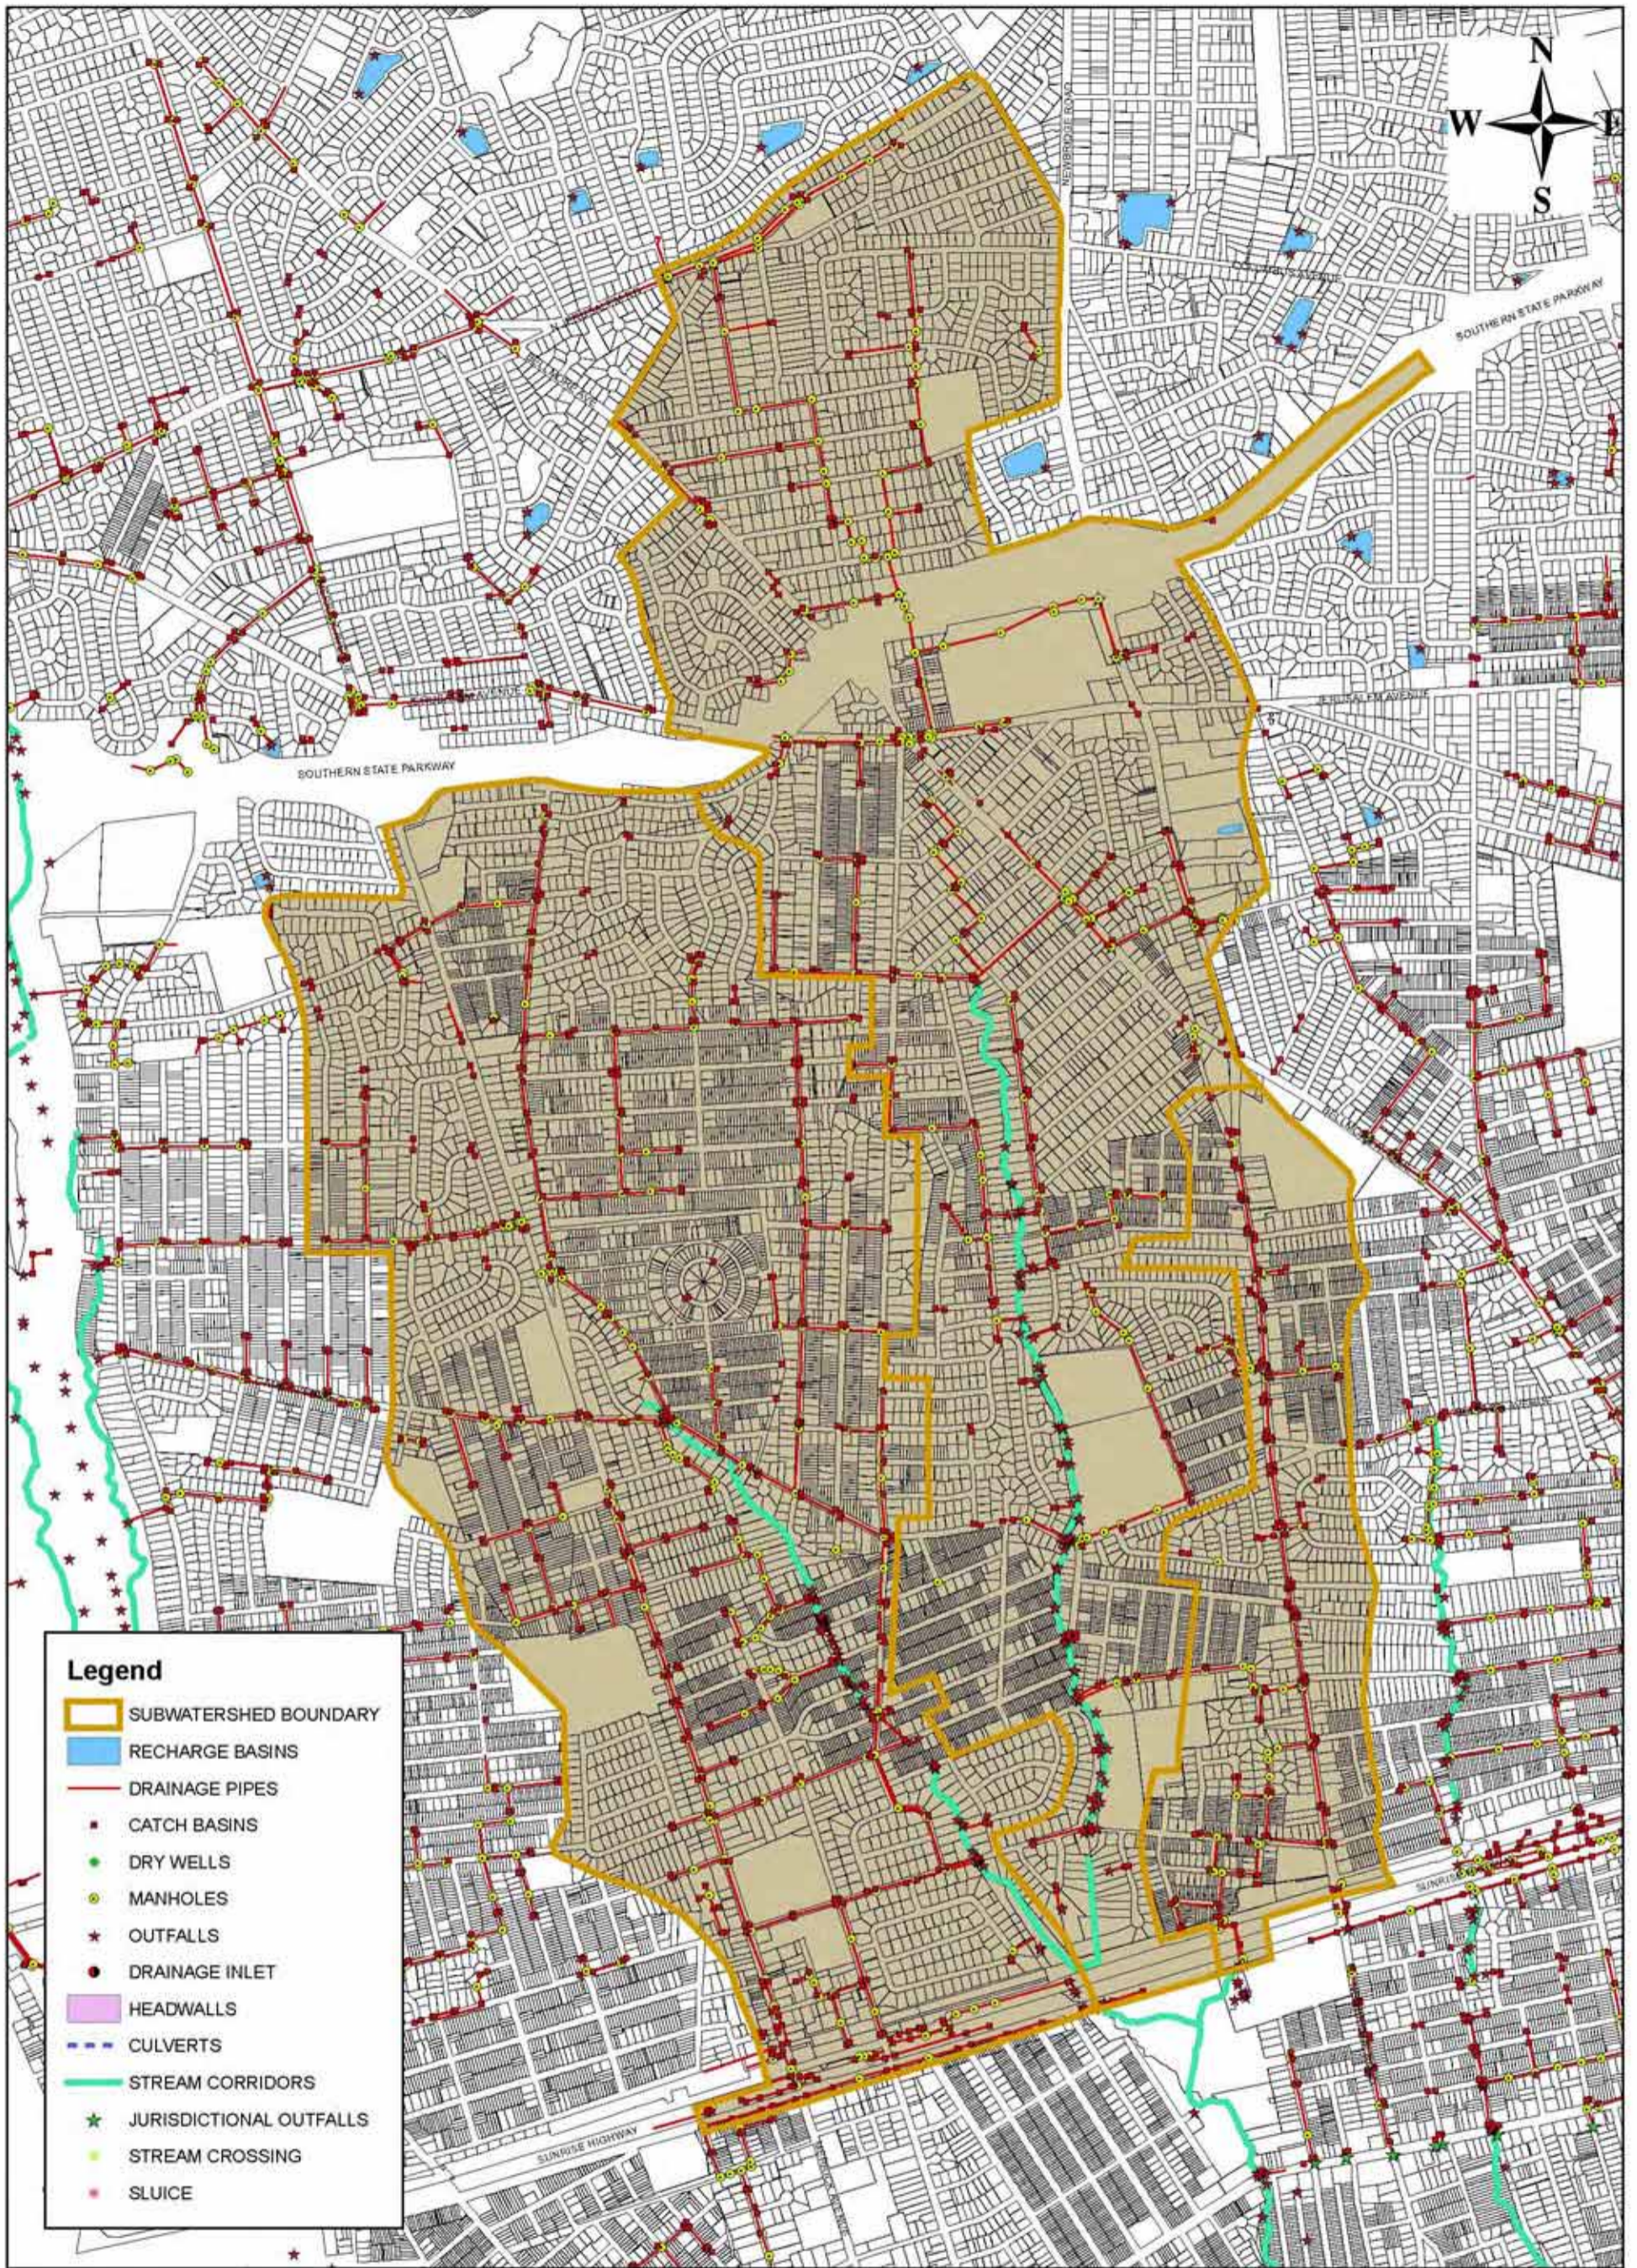
**MAP 2-1**  
**NASSAU COUNTY STORMWATER**  
**MANAGEMENT PROGRAM**  
**STORMWATER RUNOFF IMPACT ANALYSIS**  
**DRAINAGE INFRASTRUCTURE**  
**CEDAR SWAMP SUBWATERSHED**

Using the mapping developed in Section 2.1.1, areas with incomplete drainage mapping were identified. A field survey of the drainage infrastructure in those locations was conducted. This task was performed in conjunction with the Stream Assessment described in Section 2.3. During the assessment, the stream corridor was walked to verify the mapped outfalls and to identify other locations where storm runoff appeared to be directly entering the stream. The drainage infrastructure upstream of each outfall was then field verified to identify the extent of the drainage infrastructure contributing to each outfall. The drainage infrastructure of the Cedar Swamp Creek subwatershed is shown on Map 2-1.
