Greenman-Pedersen, Inc.

**Community Development Block Grant – Disaster Recovery (CDBG-DR)
Governor’s Office of Storm Recovery (GOSR)
Community Reconstruction Project No. 332960**

**Drainage Study – FINAL
February 9, 2018**

**Lido Beach and Point Lookout Drainage Study
Hamlets of Lido Beach and Point Lookout,
Town of Hempstead, Nassau County, New York**

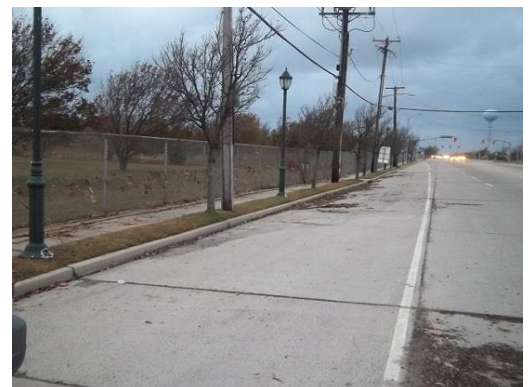
Image above was taken following Sandy, facing east along Lido Blvd. Notice High-water mark visible on the chain link fence.

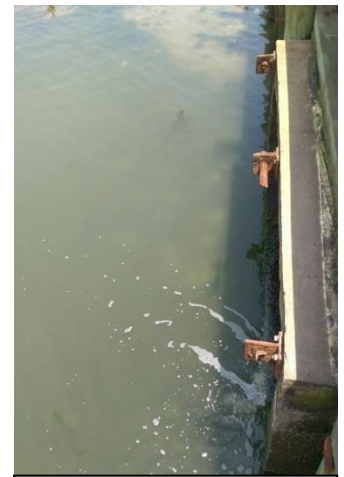
Image above showing remnants of tidal gate at existing outfall location.

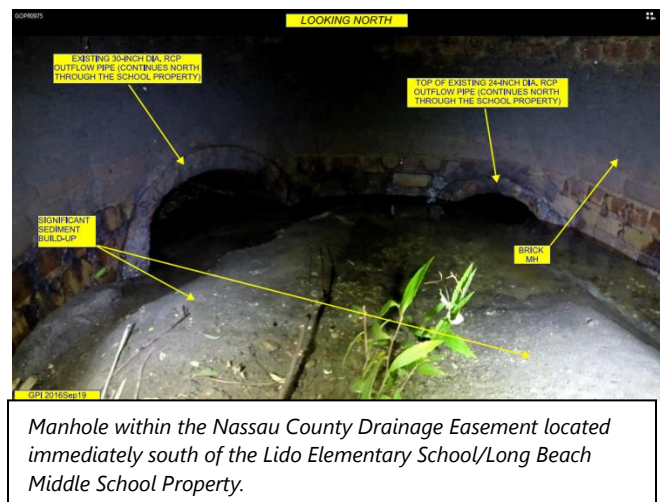
GPI's review of the digital video recorded in the structures in proximity to the LE/LBMS property and the above noted Nassau County drainage easement revealed medium/heavy sedimentation within the structures and pipes, which is indicative of difficult drainage system maintenance and/or a direct result of damage caused by Superstorm Sandy, Hurricane Irene and Tropical Storm Lee. Robust maintenance practices, which remove sediment, trash, and debris from roadways and drainage pipe networks, can help mitigate flooding and related damage and erosion. Additionally, these practices can also help protect stormwater, stream, and surface water quality. Sediment removal is particularly important because metals, pesticides, and other pollutants are often physically or chemically bound to the dirt and organic leaf materials that wash from roadways and other paved surfaces. Measures employed to facilitate the cleaning of difficult to reach areas will enable a robust maintenance program to be continued. A robust maintenance program will maintain drainage system functionality, especially within this project area where tidal influences can deposit sediment into the drainage infrastructure more rapidly and with greater volume than areas not influenced by tidal action. A robust maintenance program which removes this sediment before it is discharged into storm sewers and drainage courses helps improve water quality, and is consistent with current stormwater Best Management Practices (BMP).

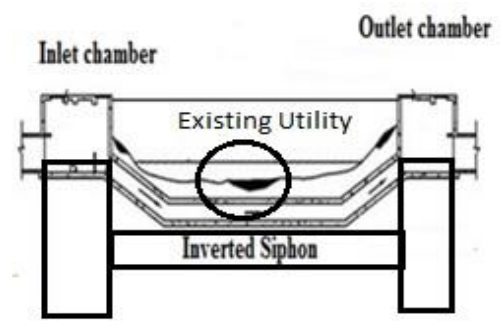
The profile displayed in Appendix E shows an inverted siphon in the existing drainage system as it crosses beneath Lido Boulevard. An inverted siphon is constructed to allow stormwater to flow beneath obstructions, such as utilities. The siphon flows at full capacity and is under pressure and ideally must have a velocity greater than 3 ft/sec to maintain a self cleaning velocity. Inverted siphons do not operate on physical pipe slope, but rather hydraulic slope, or the difference in the water surface elevations within the manholes on each end of the inverted siphon. Under these conditions, inverted siphons inherently require regular maintenance as they act as a “trap” for sediment carried in stormwater runoff. In this instance, the 30-inch diameter RCP drainage pipe could not be installed on a continuous grade beneath Lido Boulevard due to the presence of an existing 36-inch diameter sanitary sewer interceptor that runs parallel to Lido Boulevard. To get the drainage trunk line across Lido Boulevard, it was necessary to construct an abrupt vertical drop in the drainage pipe profile (i.e., construct an inverted siphon) so that it would pass beneath the existing sanitary sewer interceptor. See Figure-6 for System 1 location, watershed area and inverted siphon location.

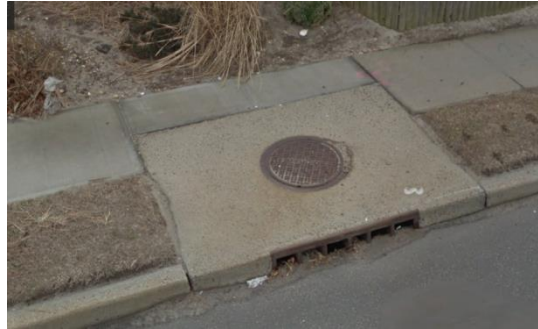
the hydraulic capacity of each curb inlet. However, it is noted that although the hydraulic efficiency of the inlet is reduced, an increase in rider safety and comfort is achieved as a by-product of reducing the severe depression in front of the inlet. The clear heights of the curb inlet openings and roadway profile depression at the inlets have been significantly reduced as shown in the image below.

Multiple Lido Boulevard asphalt overlays have significantly reduced the hydraulic efficiency of the existing curb inlets.

will be replaced with drainage structures equipped with reticuline grates and curb boxes. The combination grate and curb box has a much greater hydraulic capacity than a curb inlet casting, particularly for on-grade installations. To reduce the potential for Lido Boulevard stormwater ponding, the intent is to replace each single curb inlet casting with (2) standard NYSDOT reticuline grates and curb boxes. This proposed alternative will increase the surface inlet capacity and the ability of stormwater runoff to enter the drainage system. This action will decrease the spread width of slow moving stormwater runoff travelling against the curb line of the relatively flat Lido Boulevard roadway profile gradients. The installation of reticuline grates with curb boxes will also minimize roadway profile depressions at grate locations, in turn maintaining rider comfort and safety. Additionally, maintenance of combination inlets is facilitated by the fact the grate is removable, providing easy access to the inlet drainage structure and associated storm drain system, through the 2.5-ft. X 4-ft. rectangular opening. The same cannot be said of curb inlets, whose sole access is through the 2 ft. diameter manhole casting in the top slab of the curb inlet drainage structure. Given the critical function of Lido Boulevard as a coastal evacuation route, the redundancy provided by combination inlets and their improved maintenance access are advantageous drainage system characteristics consistent with Lido Boulevard's critical function. A typical NYSDOT reticuline grate and curb box is shown below.
