Greenman-Pedersen, Inc.

**Community Development Block Grant – Disaster Recovery (CDBG-DR)
Governor’s Office of Storm Recovery (GOSR)
Community Reconstruction Project No. 332960**

**Drainage Study – FINAL
February 9, 2018**

**Lido Beach and Point Lookout Drainage Study
Hamlets of Lido Beach and Point Lookout,
Town of Hempstead, Nassau County, New York**

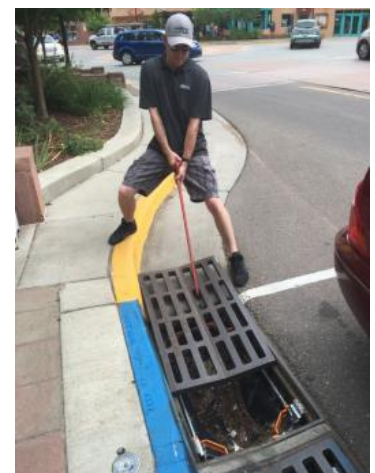
Existing Filter Bag Inserts filled with sediment and debris.

inserts so that GdB could obtain necessary drainage structure information. The Town assisted GdB in the field by cleaning, removing and reinstalling the filter bag inserts in several key structures in the Point Lookout area. The Town's assistance enabled GdB to perform the required inspection, observation, and recording of the drainage elements within each of the drainage structures. Upon completion of GdB's survey work, Town forces then reinstalled the filter bag inserts within the existing drainage structure.

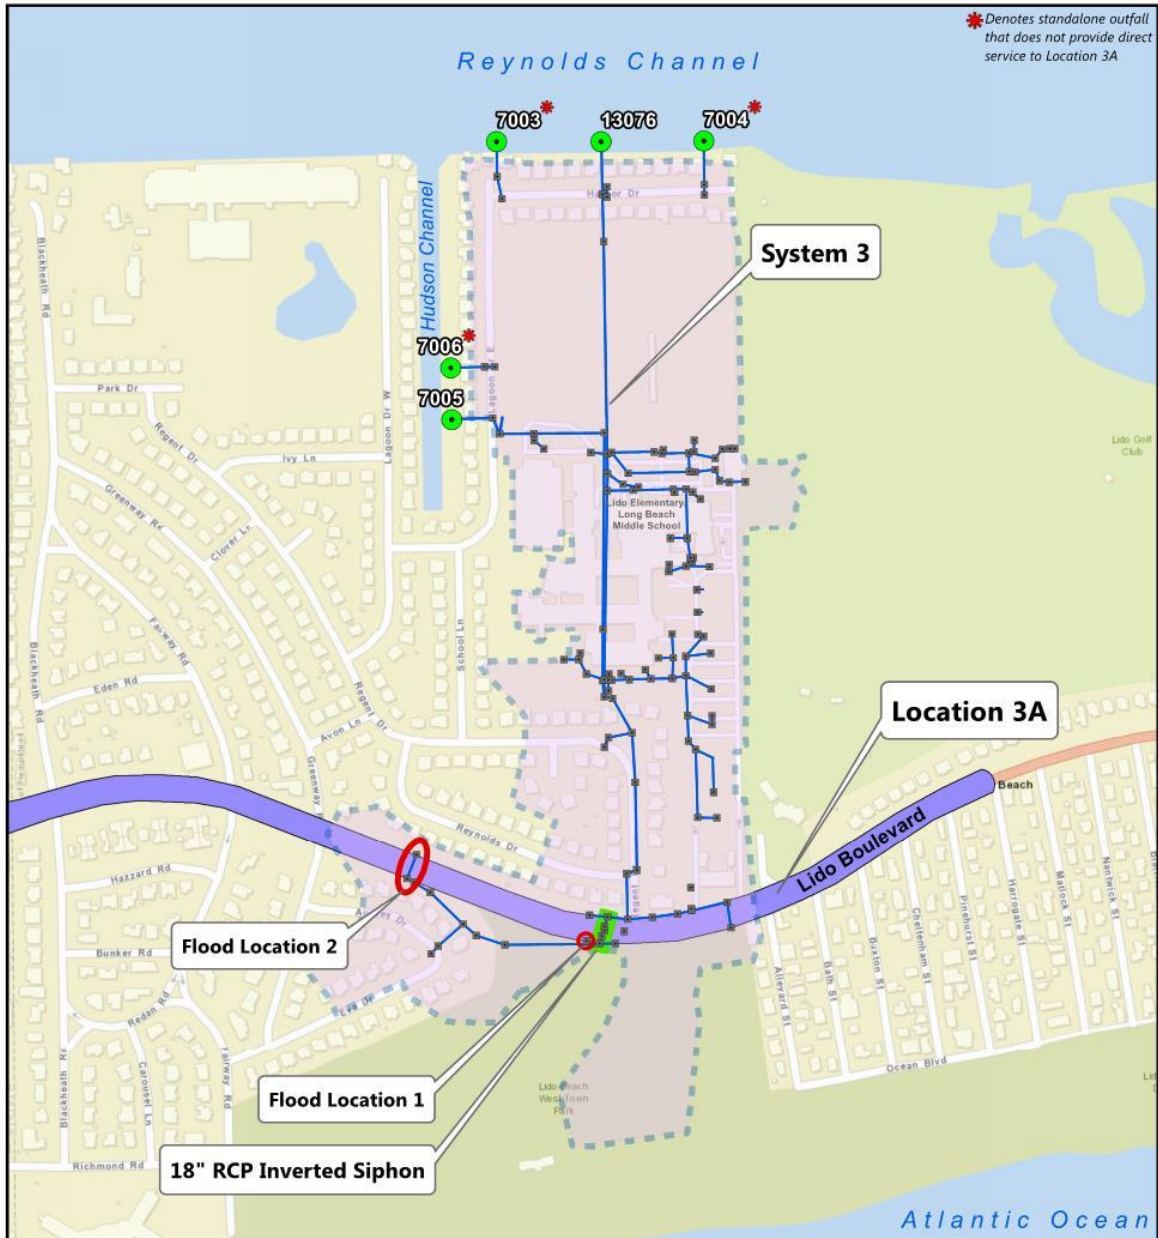
Figure-7: Location 3A- Drainage System 3 Map

Drainage System 3 existing analysis did not include tidal gates at the outfalls. See Table-7 for results from the existing system 3 hydraulic analysis. See Figure-7 for System 3 location and watershed area. Note that outfalls 7003, 7004 and 7006 do not provide direct service to Location 3A but are included in the existing hydraulic model used to evaluate potential flooding conditions within the Drainage System 3 watershed area.

ponding at Flood Locations 1 and 2 (Figure-7) for the 10-year storm event with Minor Coastal Flooding tidal conditions, has been eliminated with the implementation of a tidal backflow preventer. Refer to Appendix D for tabular results.

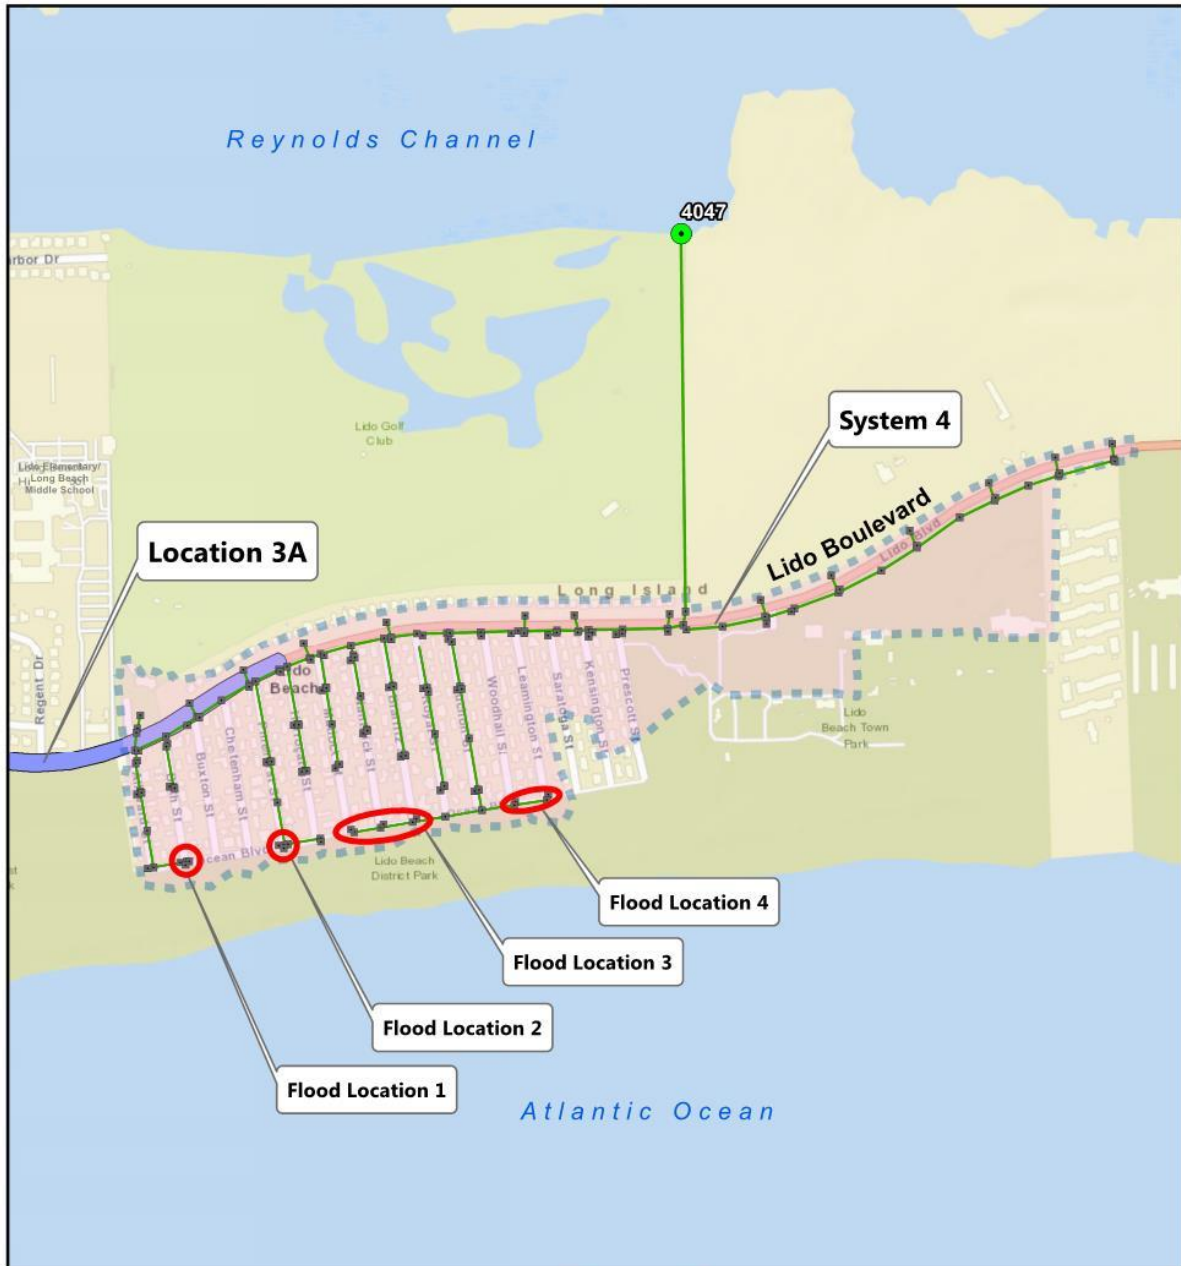
Figure-8: Drainage System 4

Conclusion: The results of the System 4 Existing hydraulic analyses revealed that for the 2-year and 10-year storm events, there are **no** System 4 hydraulic deficiencies within Lido Boulevard Location 3A for all (3) tidal parameters. Although outside of Lido Boulevard Location 3A, it is noted that Drainage System 4 existing hydraulic analysis indicates flooding does occur south of Location 3A, as shown on Figure 8. The flooding occurs within an area identified as Ocean Boulevard Location 3D, which is discussed later in this report. Refer to Appendix D for tabular results.

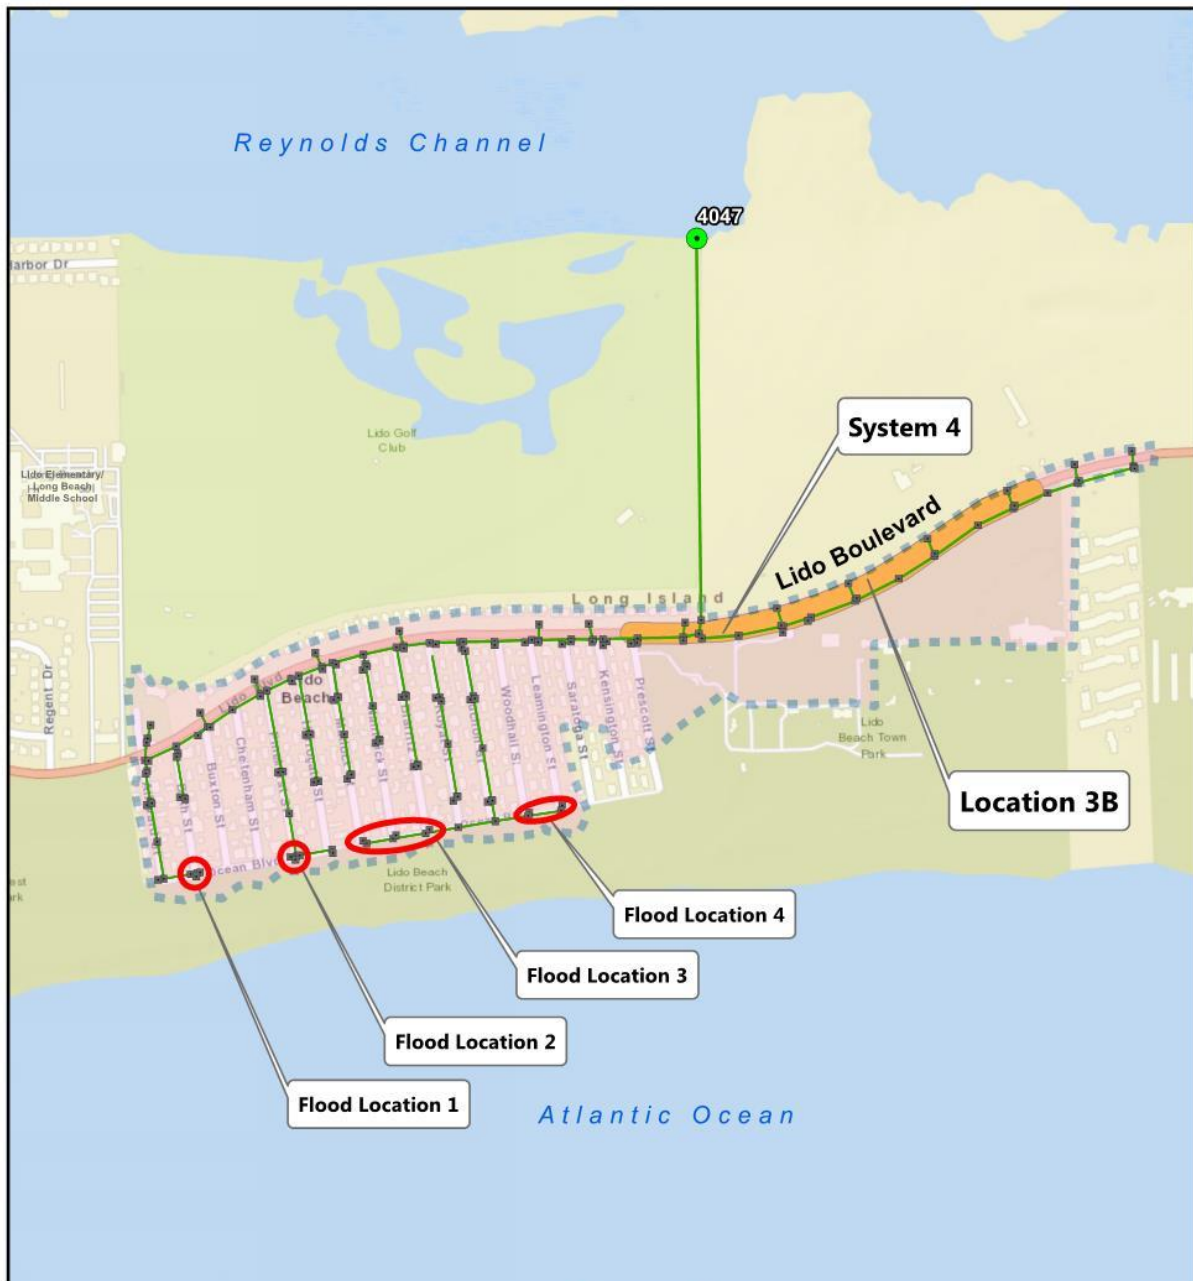
Figure-9: Location 3B – Drainage System 4 Map

Conclusion: The results of the System 4 Existing hydraulic analyses revealed that for both the 2-year and 10-year storm events, there are **no** System 4 hydraulic deficiencies within Lido Boulevard Location 3B for all (3) tidal parameters. Although outside of Lido Boulevard Location 3B, it is noted that Drainage System 4 Existing hydraulic analysis indicates flooding does occur southwest of Location 3B, as shown on Figure 9. The flooding occurs within an area identified as Ocean Boulevard Location 3D, which is discussed later in this report. Refer to Appendix D for tabular results.

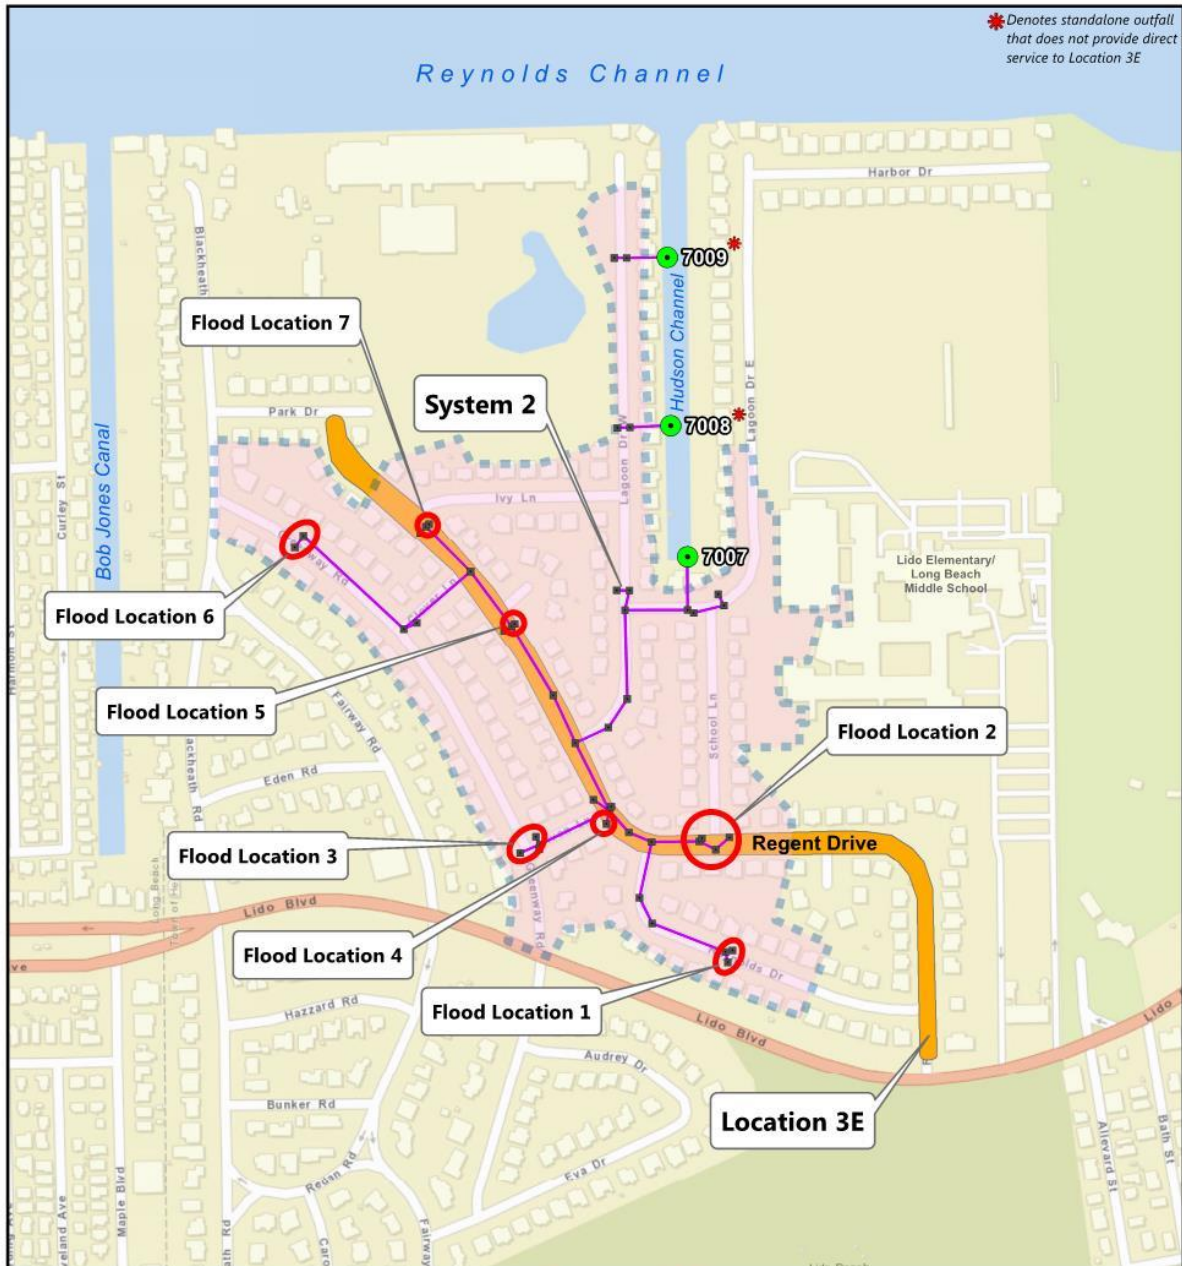
Figure-13: Location 3E- Drainage System 2 Map

Figure-13 shows (7) Drainage System 2 Flood Locations. Flood Locations 2, 4, 5 and 7 lie within Regent Drive Location 3E. Under Alternative "A," only Flood Location 2 experiences stormwater ponding for the 10-year storm event occurring with Mean High Tide outfall conditions. The ponding that had occurred at Flood Location 5 under existing conditions for these same storm and tidal parameters has been eliminated. Under Alternative "A," only Flood Locations 5 and 7 experience ponding conditions for the 10-year storm occurring with Minor Coastal Flooding tidal conditions. The ponding that had occurred at Flood Locations 2 and 4 under existing conditions for these same storm parameters has been eliminated.

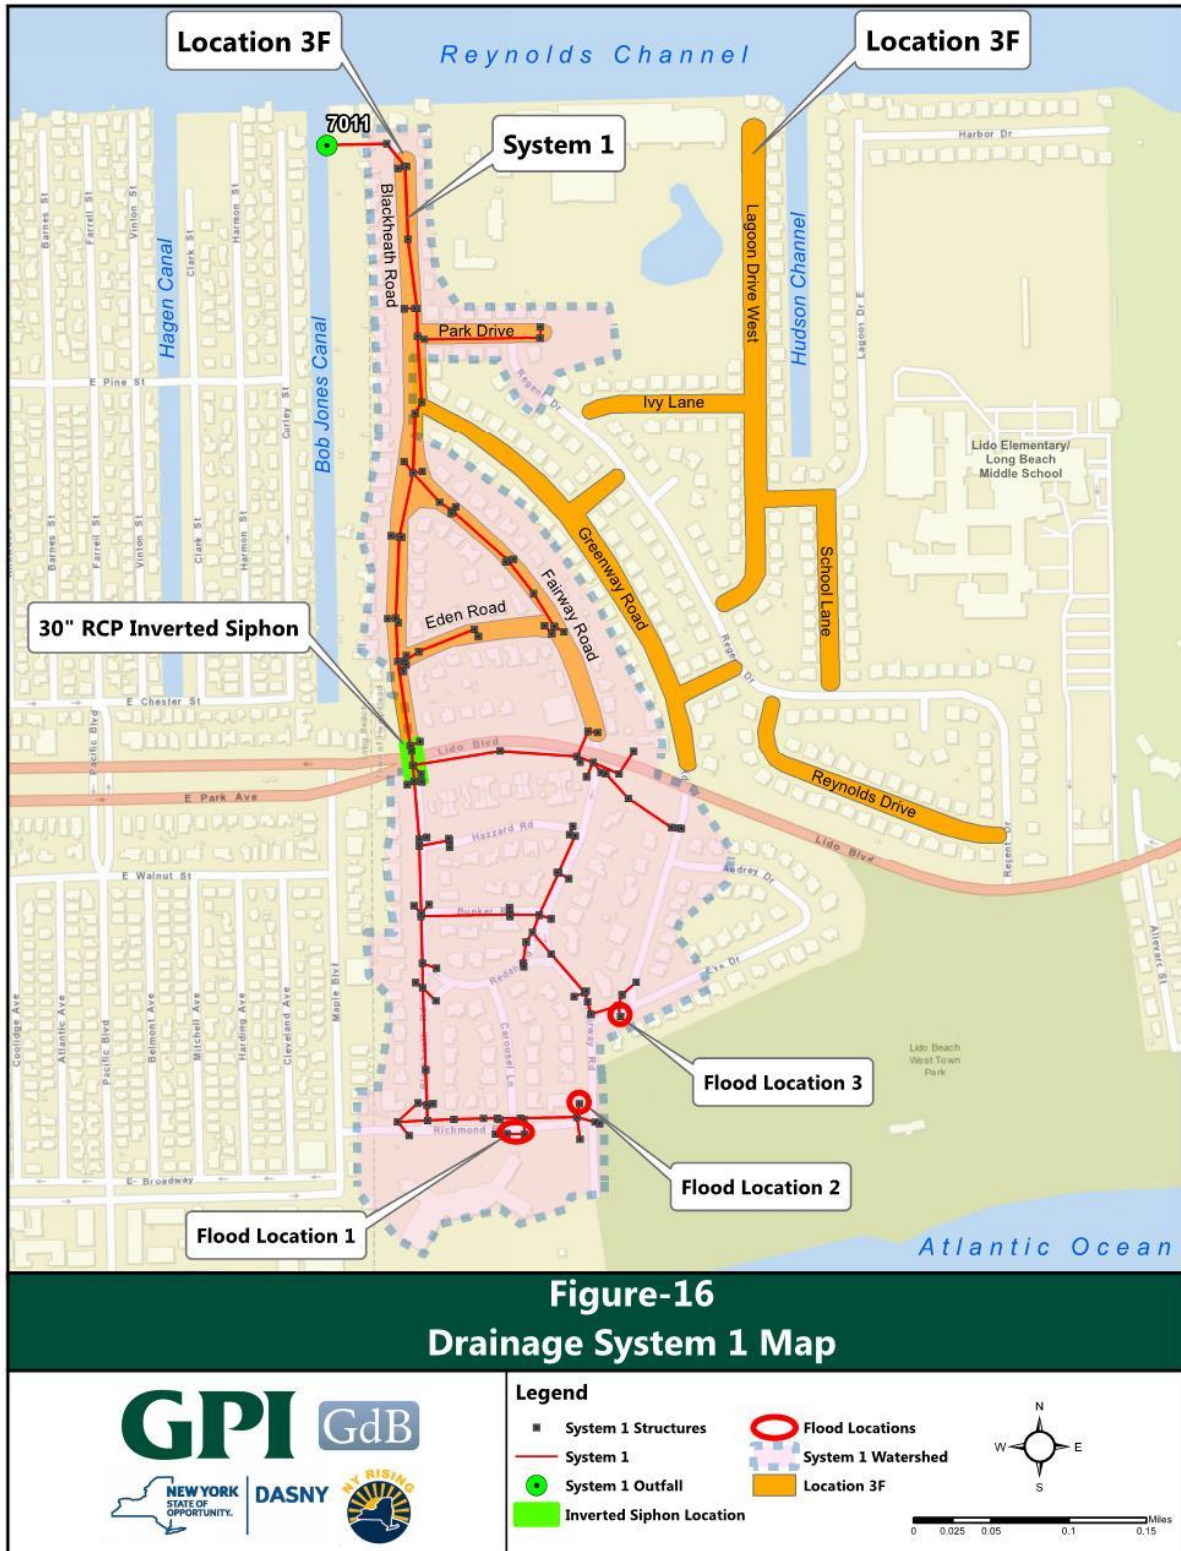
Figure-16: Location 3F- Drainage System 1 Map

Conclusion: The results of the System 1 Existing hydraulic analyses reveal that for both the 2-year and 10-year storm events, there are **no** Drainage System 1 hydraulic deficiencies within Lido North Community Location 3F for all (3) tidal parameters. Although outside of Location 3F, it is noted that Drainage System 1 existing hydraulic analysis indicates flooding does occur south of Lido Boulevard, as shown on Figure 16. See Appendix D for tabular results.

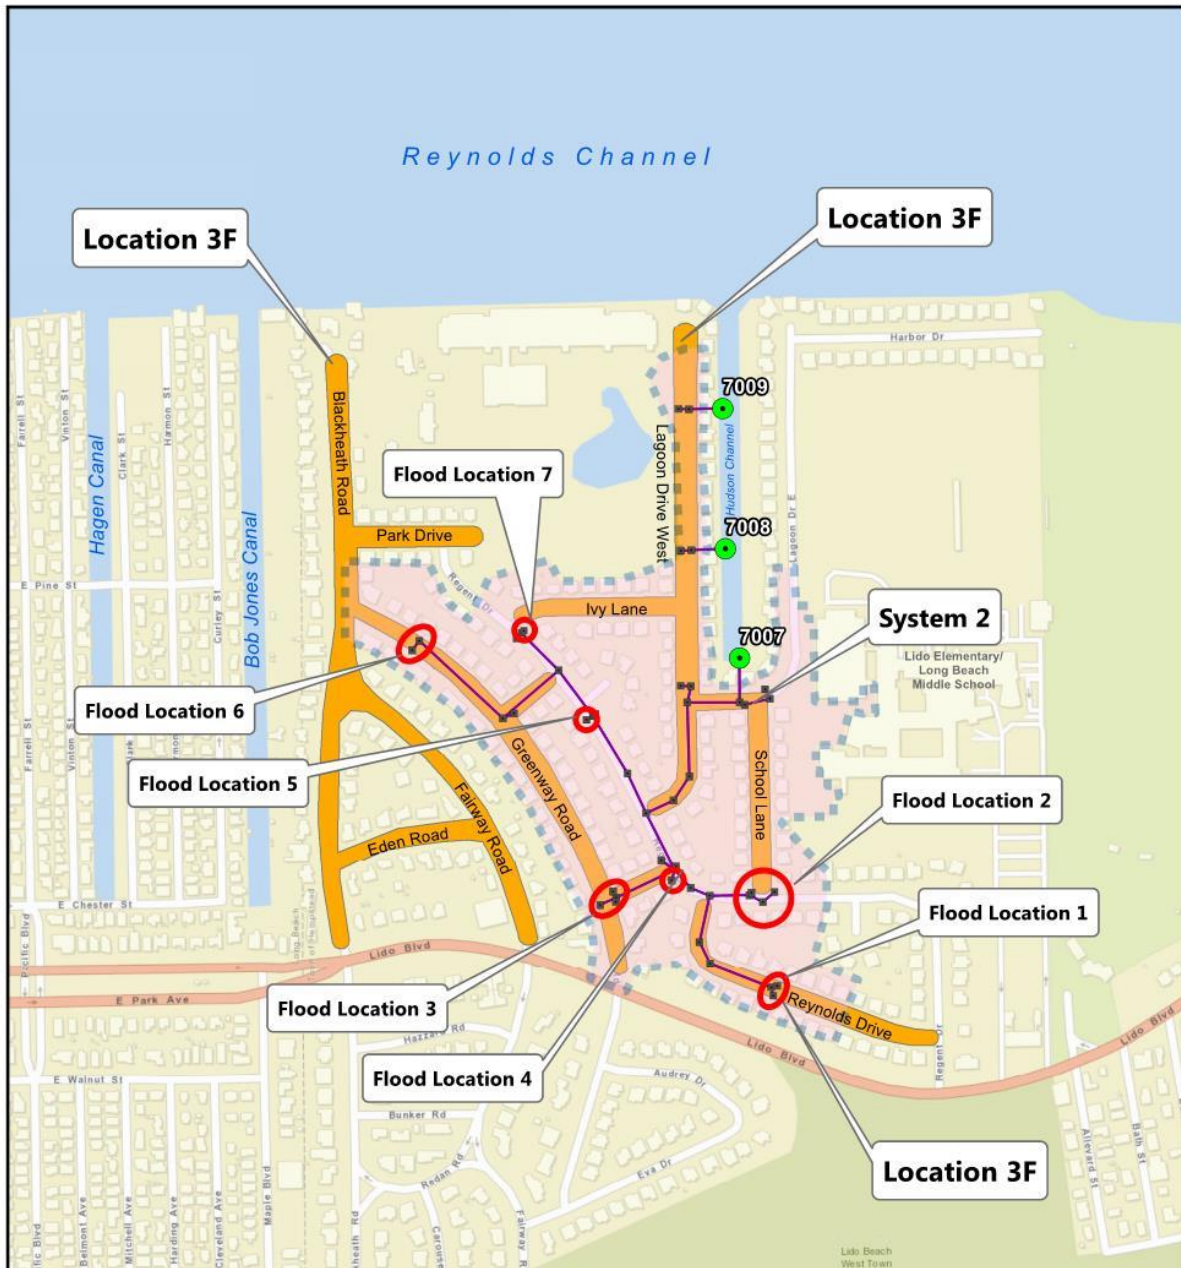
Figure-17: Location 3F- Drainage System 2 Map

Conclusion: The results of the System 2 Existing hydraulic analyses within Lido North Community Location 3F revealed the system can adequately handle the 2-year storm event for all (3) tidal outfall parameters. For the 10-year storm event and Mean Low Tide outfall conditions, there are no System 2 hydraulic deficiencies evident within Lido North Community Location 3F.

However, for the 10-year storm event under Mean High Tide and Minor Coastal Flooding tidal conditions, the hydraulic grade line exceeds the rim elevations of several structures within Lido North Community Location 3F.

Figure-17 shows (7) Drainage System 2 Flood Locations. Flood Locations 2, 4, 5 and 7 lie within Regent Drive Location 3E, which has been discussed earlier in this report. Flood Locations 1, 3 and 6 are serviced by Drainage System 2 and lie within Lido North Community Location 3F. All (3) of these flood locations experience stormwater ponding for the 10-year storm event occurring with either Mean High Tide or Minor Coastal Flooding tidal conditions.

Figure-17 shows (7) Drainage System 2 Flood Locations. Flood Locations 2, 4, 5 and 7 lie within Regent Drive Location 3E, which has been discussed earlier in this report. Flood Locations 1, 3 and 6 are serviced by Drainage System 2 and lie within Lido North Community Location 3F. Under Alternative “A,” only Flood Locations 3 and 6 experience stormwater ponding for the 10-year storm event occurring with Mean High Tide or Minor Coastal Flooding tidal conditions. The ponding that had

occurred at Flood Location 1 under existing conditions for these same storm and tidal parameters has been eliminated.

When compared to existing conditions, it can be readily seen that Alternative "A" (introduction of check valves) eliminated flooding at multiple locations within the Drainage System 2 service area.

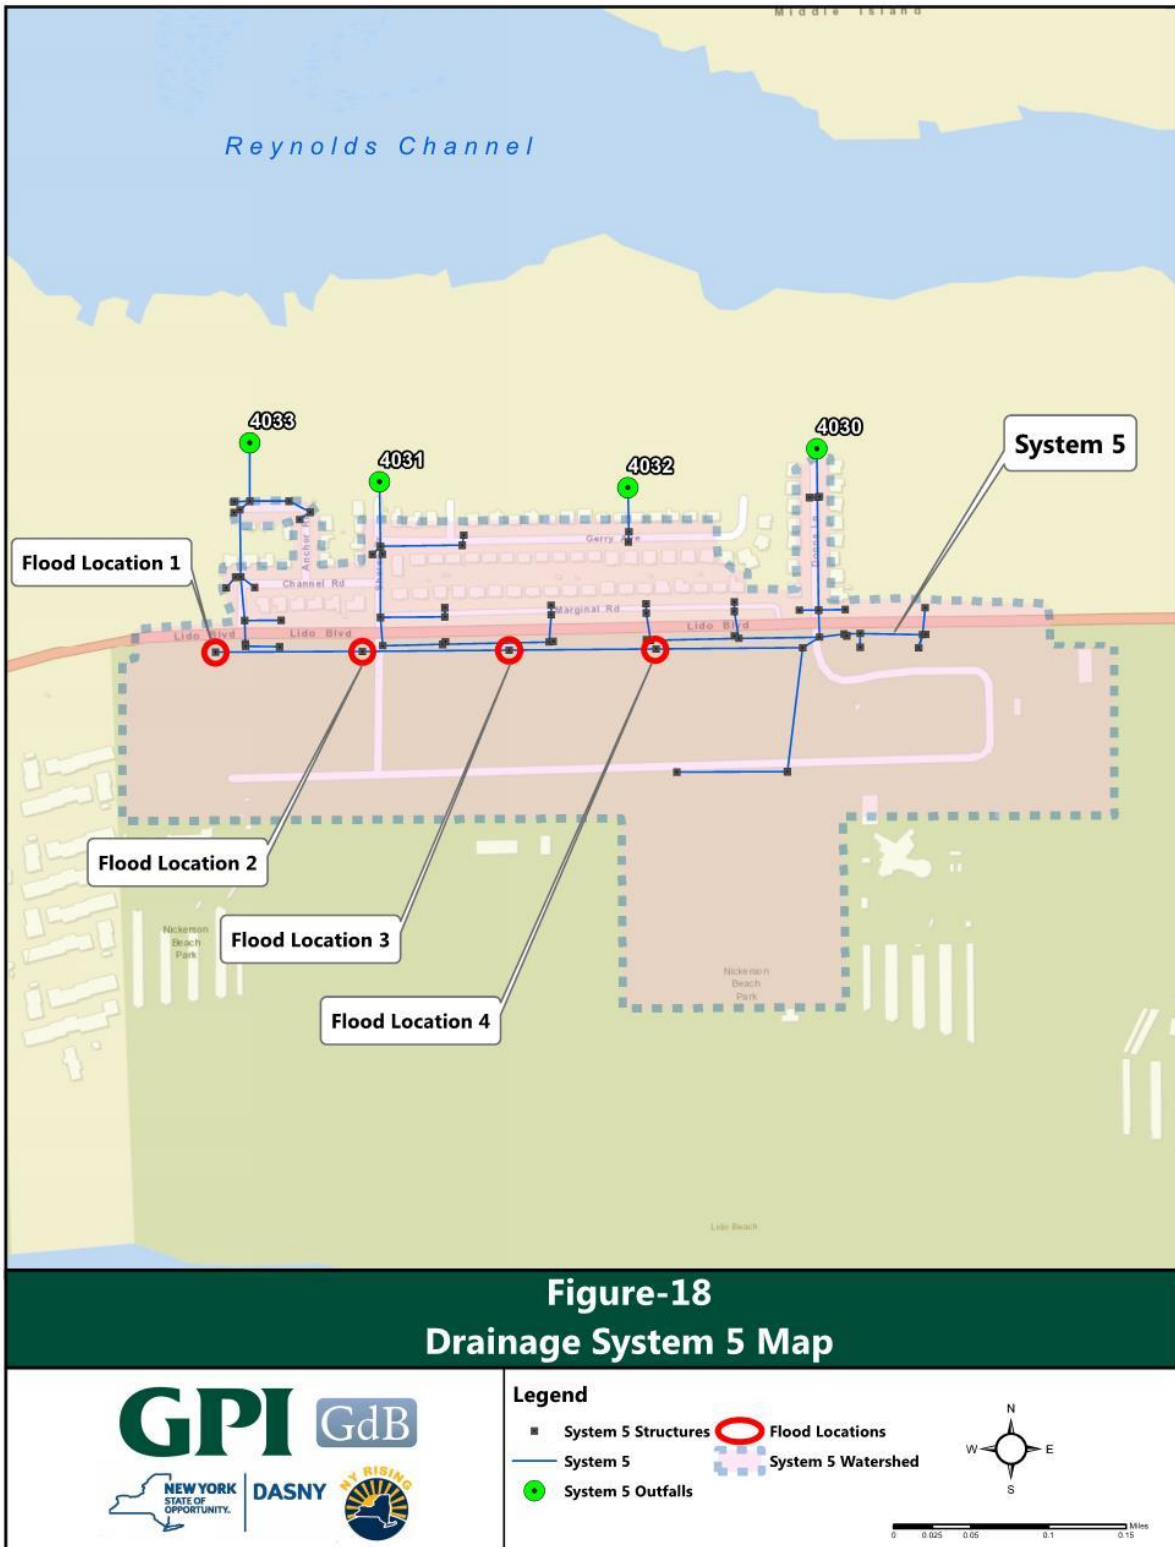
Figure-18: Drainage System 5 Map

Conclusion: The results of the System 5 Existing hydraulic analyses reveal that for both the 2-year and 10-year storm events, there are no System 5 hydraulic deficiencies on Lido Boulevard or within the residential community north of Lido Boulevard. All (4) flood locations identified in Figure-18 are located off-road and within the Nassau County Nickerson Beach Park property. Drainage structure field survey was inconclusive within this property and record/construction plan information was not available. For drainage modeling purposes, an implicit drainage network was established within the park property. The network was established to ensure the total runoff from the park property's 60 (+/-) acres was included in the System 5 drainage analysis. The exact existing drainage network and connections within the park property are unknown. However, assuming complete capture of the park property runoff is a very conservative approach to the drainage model and its results.

Conclusion: The results of the System 5 – Alternative "A" hydraulic analyses reveal that for both the 2-year and 10-year storm events, there are no System 5 hydraulic deficiencies on Lido Boulevard or within the residential community north of Lido Boulevard. All (4) flood locations identified in Figure-18 are located off-road and within the Nassau County Nickerson Beach Park property. Drainage structure field survey was inconclusive within this property and record/construction plan information was not available. For drainage modeling purposes, an implicit drainage network was established within the park property. The network was established to ensure the total runoff from the park property's 60 (+/-) acres was included in the System 5 drainage analysis. The exact existing drainage network and connections within the park property are unknown. However, assuming complete capture of the park property runoff is a very conservative approach to the drainage model and its results.

valves) reduced the HGL elevations for the drainage structures situated within Flood Locations 1 through 4 in Figure-18, particularly for the 10-year storm event under Minor Coastal Flooding tidal conditions. A reduction in HGL is directly related to a reduction in the magnitude of flooding.

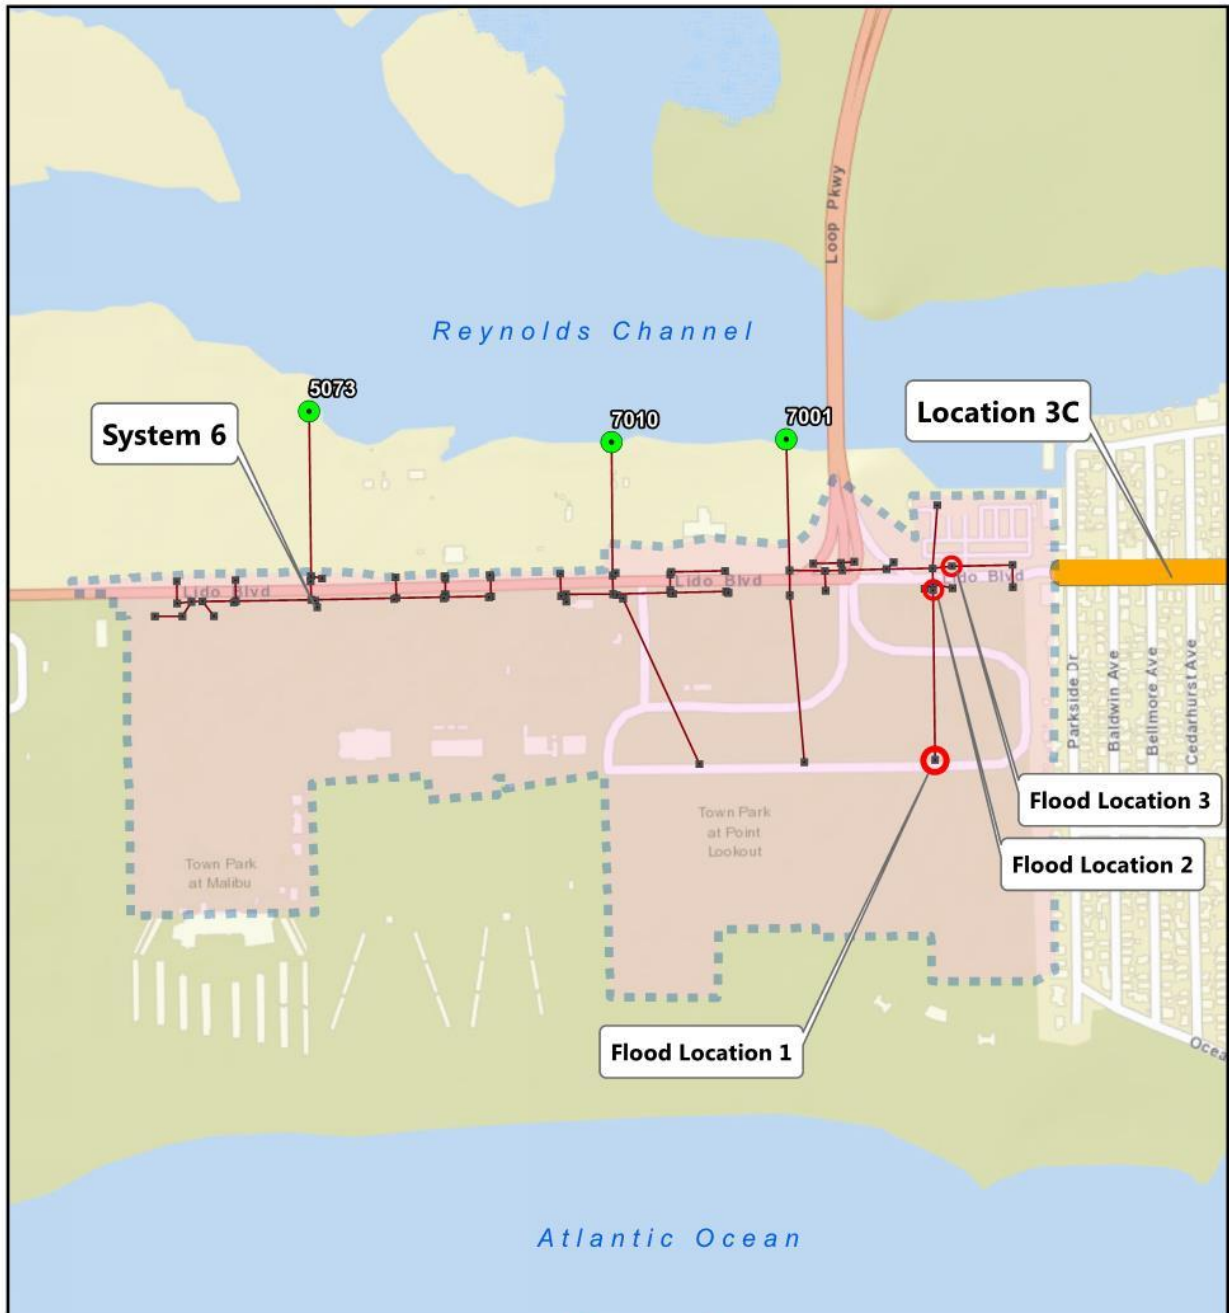
Figure-19: Drainage System 6 Map

Conclusion: The results of the System 6 Existing hydraulic analyses reveal that the system can adequately handle the 2 year storm event for all (3) tidal parameters. For the 10-year storm event, there are no hydraulic deficiencies evident for the Mean Low Tide scenario.

However, for the 10-year storm event under Mean High Tide conditions, ponding can be expected to occur within Flood Location 1, as identified in Figure-19. Flood Location 1 is off-road and within the Town Park at Point Lookout property. Drainage structure field survey was inconclusive within this property and record/construction plan information was not available. For drainage modeling purposes, an implicit drainage network was established within the park property. The network was established to ensure the total runoff from the park property’s 83 (+/-) acres was included in the System 6 drainage analysis. The exact existing drainage network and connections within the park property are unknown. However, assuming complete capture of the park property runoff is a very conservative approach to the drainage model and its results.

It is only for the 10-year storm event under Minor Coastal Flooding tidal conditions that ponding occurs on Lido Boulevard. This ponding occurs at Flood Locations 2 (CB 1015) and 3 (CB 1020), which are curb inlets located on the south and north sides of Lido Boulevard, respectively.

However, for the 10-year storm event under Mean High Tide conditions, ponding can still be expected to occur within Flood Location 1, as identified in Figure-19. Flood Location 1 is off-road and within the Town Park at Point Lookout property. Drainage structure field survey was inconclusive within this property and record/construction plan information was not available. For drainage modeling purposes, an implicit drainage network was established within the park property. The network was established to ensure the total runoff from the park property’s 83 (+/-) acres was included in the System 6 drainage analysis. The exact existing drainage network and connections within the park property are unknown. However, assuming complete capture of the park property runoff is a very conservative approach to the drainage model and its results.

When compared to existing conditions, it can be seen that Alternative “A” (introduction of tidal check valves) has eliminated the ponding at Lido Boulevard Flood Locations 2 and 3 for the 10-year storm event under Minor Coastal Flooding tidal conditions.

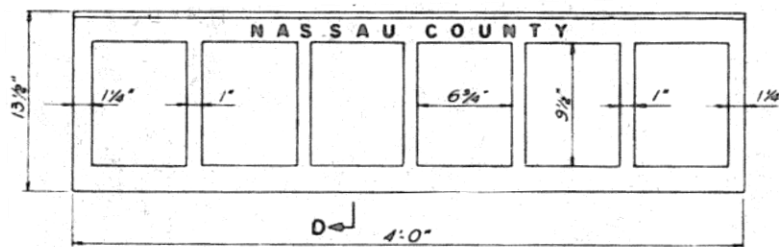
Typical Curb Inlet Casting

Curb inlets perform best when located at dead-low points in the roadway profile and when as much of the 9.5-inch curb opening height is maintained. The curb inlet openings tend to operate as an orifice, and as water ponds in front of the inlet (as it could at a dead-low point in the roadway profile), the hydraulic efficiency of the openings (i.e., orifices) increases. In summary, the efficiency of this type of structure will increase as water ponds in the roadway. This is why curb inlets are best suited for dead-low points in the roadway profile. For on-grade interception of stormwater runoff, curb inlets are not very efficient at all.

For Alternative C, the intent is to replace the existing curb inlets with new catch basins. Each curb inlet

will be replaced with drainage structures equipped with reticuline grates and curb boxes. The combination grate and curb box has a much greater hydraulic capacity than a curb inlet casting, particularly for on-grade installations. To reduce the potential for Lido Boulevard stormwater ponding, the intent is to replace each single curb inlet casting with (2) standard NYSDOT reticuline grates and curb boxes. This proposed alternative will increase the surface inlet capacity and the ability of stormwater runoff to enter the drainage system. This action will decrease the spread width of slow moving stormwater runoff travelling against the curb line of the relatively flat Lido Boulevard roadway profile gradients. The installation of reticuline grates with curb boxes will also minimize roadway profile depressions at grate locations, in turn maintaining rider comfort and safety. Additionally, maintenance of combination inlets is facilitated by the fact the grate is removable, providing easy access to the inlet drainage structure and associated storm drain system, through the 2.5-ft. X 4-ft. rectangular opening. The same cannot be said of curb inlets, whose sole access is through the 2 ft. diameter manhole casting in the top slab of the curb inlet drainage structure. Given the critical function of Lido Boulevard as a coastal evacuation route, the redundancy provided by combination inlets and their improved maintenance access are advantageous drainage system characteristics consistent with Lido Boulevard's critical function. A typical NYSDOT reticuline grate and curb box is shown below.

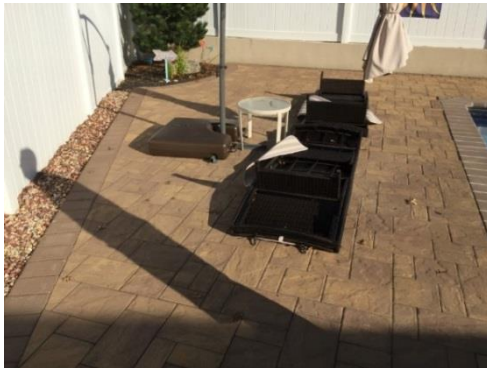
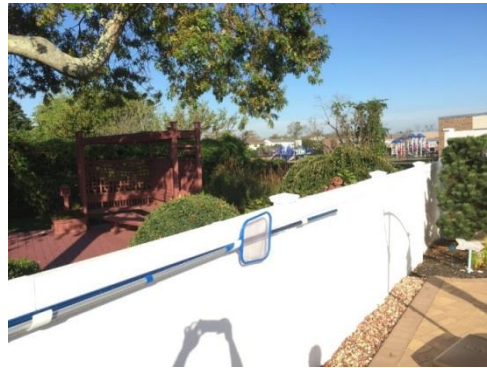
These critical drainage structures are currently very difficult to access due to the development of these private properties over time and because of the various home improvements constructed on these private properties. Difficult access translates to challenges in maintaining and cleaning these structures and the pipes within them. During the data collection phase of the study, these manholes were not visible by simple inspection of the house back yards. The manhole covers that provide access to the drainage structures for inspection and maintenance were buried under an excess of 12 inches of earth, and were located directly below the decorative vinyl fence separating the two properties. Miscellaneous shrubberies and portions of underground sprinklers had to be moved out of the way to gain access to perform inspections inside the structures.

Note decorative brick pavers, built-in pool, decorative vinyl fencing and wood deck

The intent of this proposed alternative is to provide improved access to these critical existing drainage manhole structures and pipe. Improved access would facilitate the future servicing and/or cleaning of these critical structures and pipe, which will help to improve the overall hydraulic efficiency of Drainage System 3.

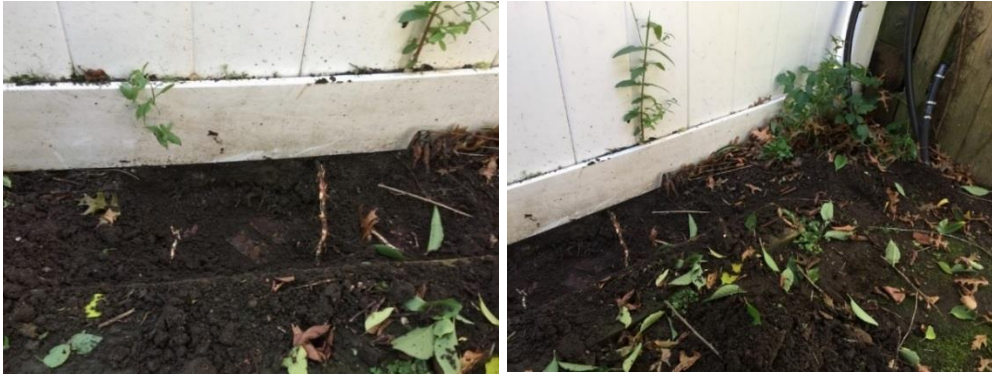
Note buried manhole under existing decorative vinyl fence
