# SILVER LAKE DRAINAGE IMPROVEMENTS STUDY FINAL REPORT

New York State Governor's Office of Storm Recovery (GOSR) –  
Funded Disaster Recovery

Nassau County Department of Public Works

**DECEMBER, 2018**

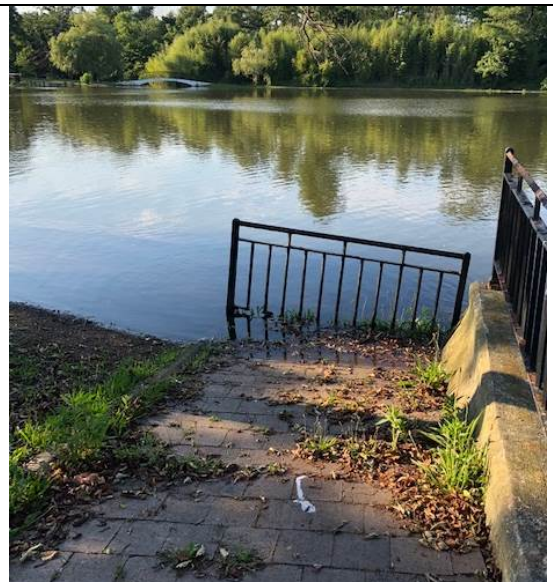
On July 10, 2018, minor flooding of Silver Lake Park was observed and documented by Nassau County DPW (Photo 5 & 6). On this date, there was no rain recorded but an offshore storm combined with a period of time three days before the new moon resulted in the tide reaching an elevation of 3.12' (NAVD), which is slightly above the top of bulkhead elevation.

Photo 6. July 10, 2018 at Silver Lake Park west of existing weir. Tidal surge has breached the top of the existing bulkhead wall (top of wall = 3.0' NAVD)

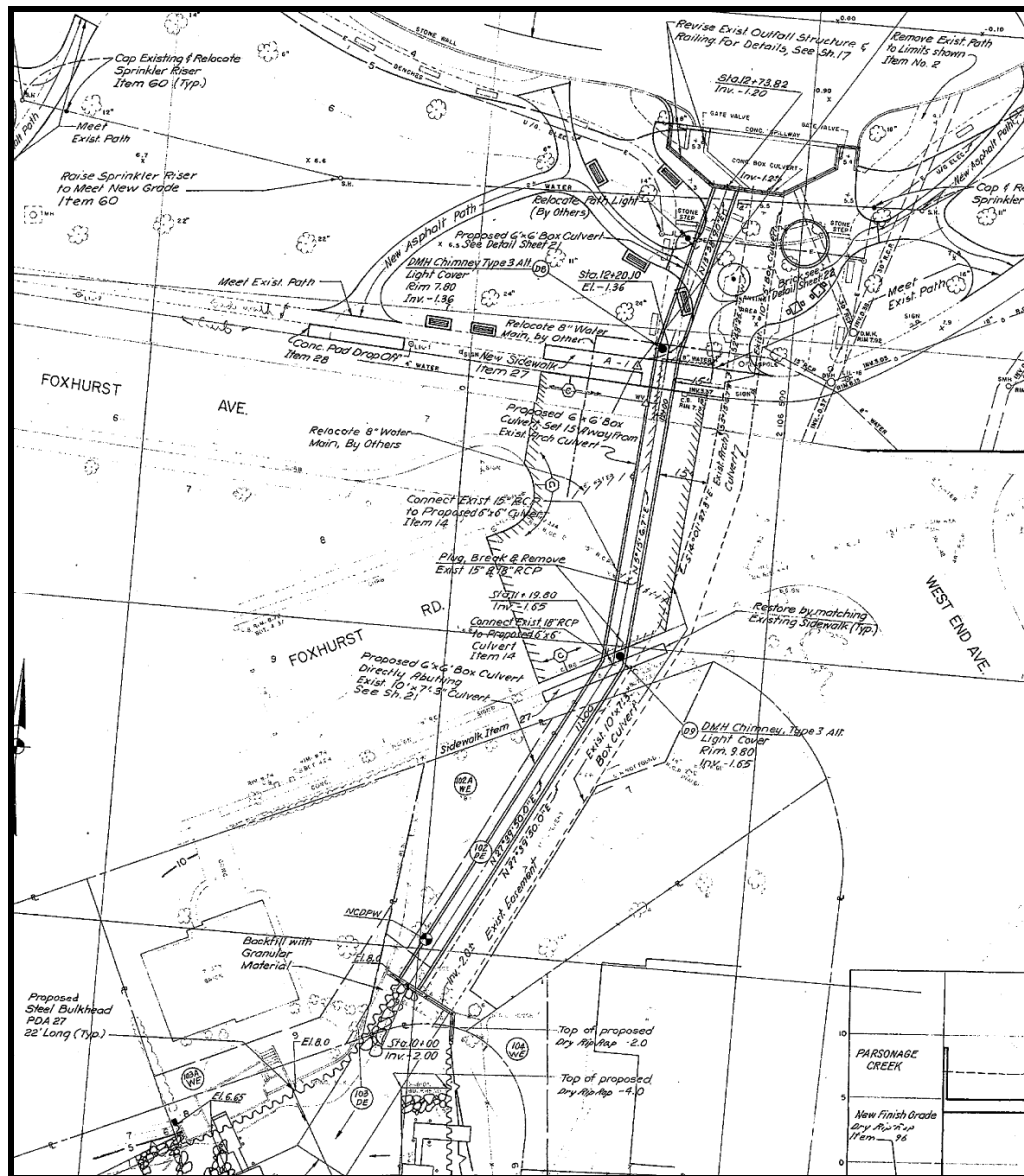
There are two existing concrete box culverts downstream of the Silver Lake weir which convey flow from the lake to the tidal waters of Parsonage Creek canal. This culvert runs transversely below Foxhurst Road and through a drainage easement on private property located on the south side of the road. From 1980 record plans, it is apparent that prior to 1980 the system only had the eastern box culvert. As shown on the 1980 record plan below (Figure II-7), this culvert transitions from a 10'x5' box culvert to a 10'x7.25' box culvert before it outfalls into the canal. At some point after 1980, an additional 6'x6' concrete box culvert was installed most likely to increase the capacity of the system to handle the stormwater flows which may have been overwhelming the original design as a result of upland development and increased impervious areas.

**Figure II-7. Portion of July, 1980 Record Plan from the NCDPW Baldwin Creek Drain Flood Relief Project**

As depicted on the 1980 record plans and shown in the photograph below the culverts terminate at the north end of Parsonage Creek Canal without any tide gates. Also evident is that the western wall of the 6'x6' culvert terminates basically in-line with a deteriorated steel bulkhead leaving insufficient room for a tide gate to be installed on the 6'x6' culvert.

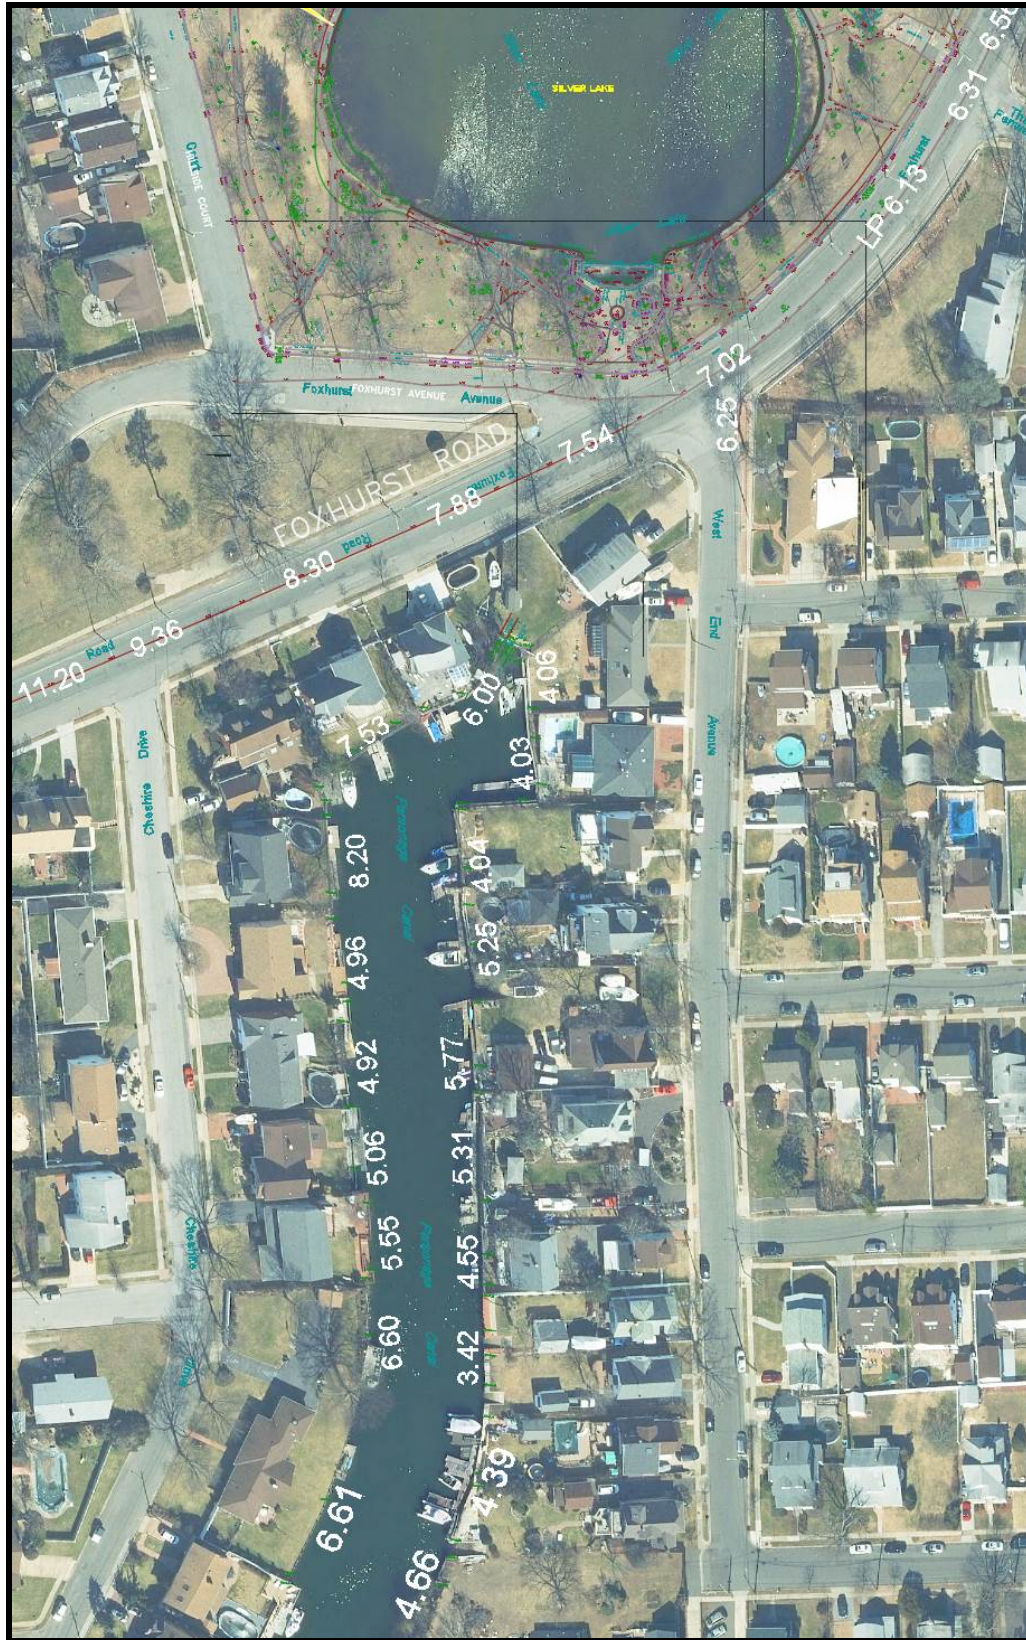
**Figure II-8. Parsonage Creek Top of Bulkhead Elevations & Foxhurst Road Crown Elevations (NAVD88)**

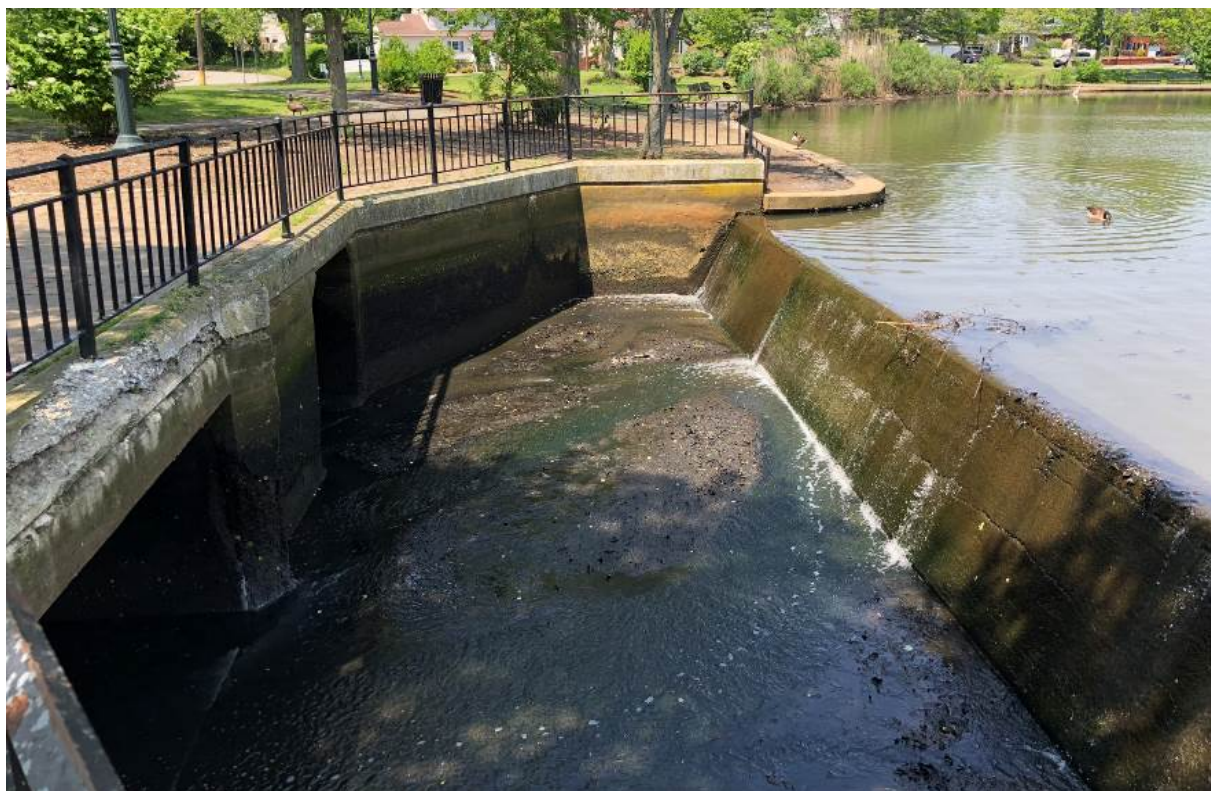
The Silver Lake weir is located on the south side of the lake and controls water surface elevations in the lake by passing base flow and stormwater over a 52 foot wide spillway. The weir elevation is at 2.0 (NAVD 88) which is approximately 1 foot below the top of bulkhead that runs around the perimeter of the lake. The 1980 Record Plan indicates that the weir length was increased to accommodate the additional 6'x6' concrete culvert installed as part of the *Nassau County DPW Baldwin Creek Drain Flood Relief Project*.

**Photo 8. Photograph of existing Silver Lake weir at low tide**

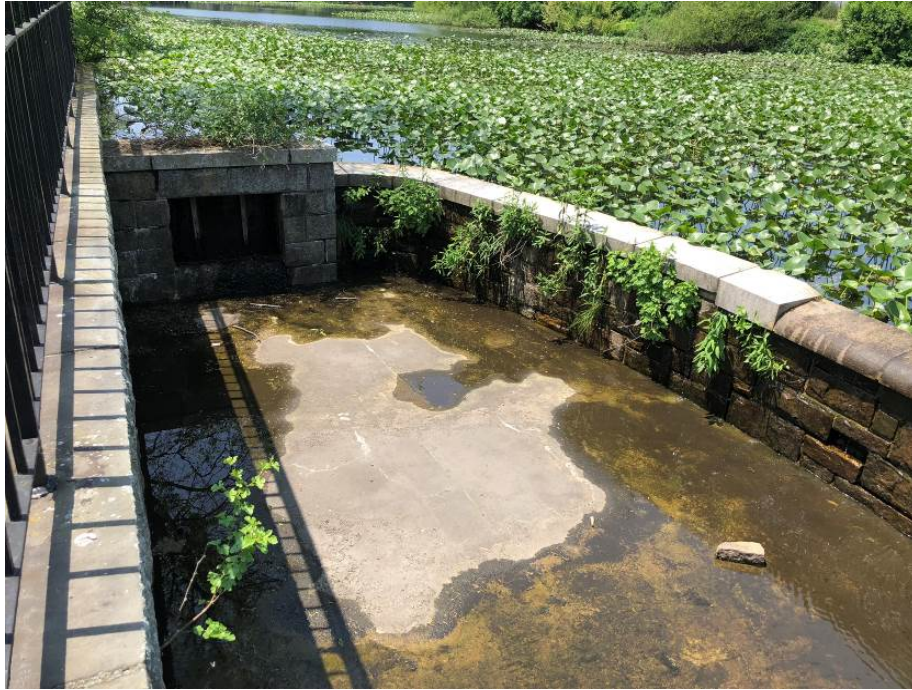
North of Merrick Road, Parsonage Creek is impounded by Lofts Pond, which receives base flow and stormwater runoff from a large upland urban watershed. As mentioned above, Lofts pond contributes constant base flow to the natural channel south of Merrick Road. Additionally, Lofts pond is equipped with a concrete/masonry weir structure that has the potential to release large flows to a 4'x8' concrete box culvert, which runs directly from Lofts Pond to Caroline's Pond. This can be considered a high flow bypass.

***Photo 11. Weir Structure at Lofts Pond***
